Structural collapse assessment of the access bridge to Hydroelectric Plant “Pacífico Mascarenhas”

The steel bridge popularly known as “Ponte da Usina”, is 54 meters long and is composed of 18 modules of 3 meters. Heavy rains that occurred on the night of 5 February 2013 at the top of the Serra do Cipó, caused an increase of the river level “Parauninha” of approximately 15 meters, causing destruction along its banks and the structural collapse of the bridge “Ponte da Usina”. This work describes the general bridge history and damages that have affected the structure in the past, the circumstances and the impacts of the collapse as well as the proposed alternatives for reconstruction of the collapsed bridge.

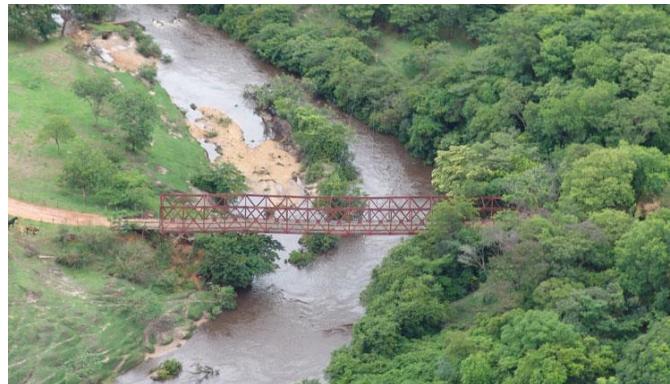
The bridge consists of a metallic structural system with a thick wooden tabulated tray. It has porticos at each end, differentiated from the porticos of the central modules. The metallic porticos are crowned by lattice arches in 5 sections along the bridge. Also, the whole bridge is composed of basic metal shapes such as I-sections, T-sections, and angle sections as shown in Fig. 1, which represents an aerial image of the steel bridge before the collapse [1].

Figure 1 Bridge “Ponte da Usina” before the collapse [1].

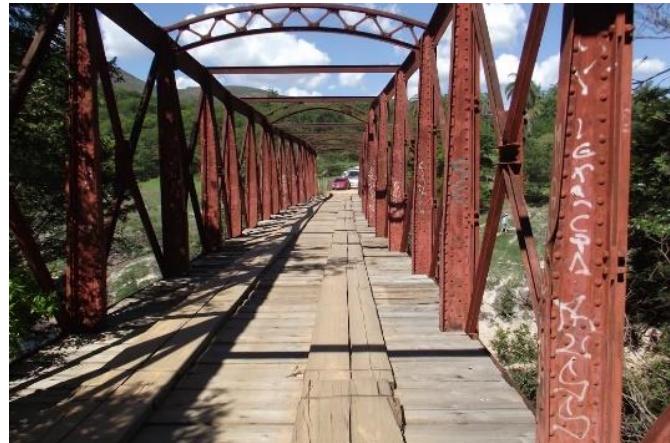
The floor table is composed of wood with an average thickness of 5 cm as shown in Fig. 2. Boards are used in the

The bridge has a reddish color, resulting from a texture mixed between the special painting for metals and the points that are in process corrosion. There are spots with graffiti in several colors, mainly on the sides of the vertical columns as shown in Fig. 2.

Figure 2 Inside part of the bridge [1].

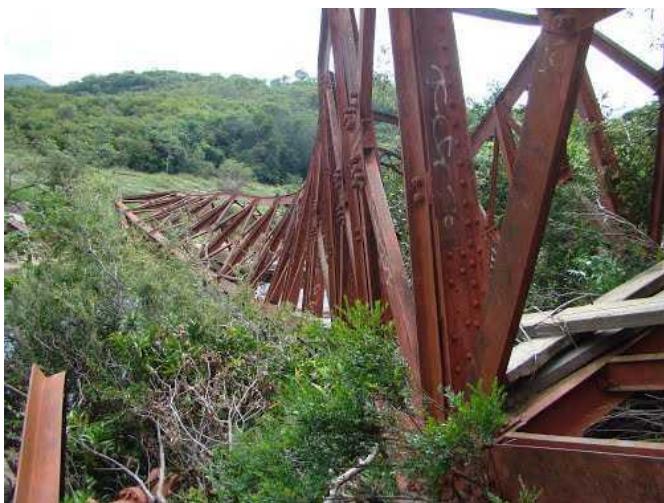
Knowing the history of degradation suffered by the "Ponte da Usina" and the conservation status of the bridge, again, due to heavy rain on the night of 5 February 2013 on the top of the Serra do Cipó, several streams that flow into the "Parauninha" river raised its level by approximately 15 meters, destroying its shores and the collapse of the steel bridge. A general view of the collapsed structure is shown in Fig. 3 and a partial view of the damaged bridge may be seen in Fig. 4.

Figure 3 General view of the collapse structure [4].

- Hypothesis 1: Recovery of the original metal structure and reassembly of the bridge;
- Hypothesis 2: Elaboration of new metallic structure design for the bridge, keeping all elements and the geometric shape similar to the original structure;
- Hypothesis 3: New solution with design elaboration in mixed structure (concrete/metallic), with a geometric shape different from the original, with a capacity equal to 45 tons.

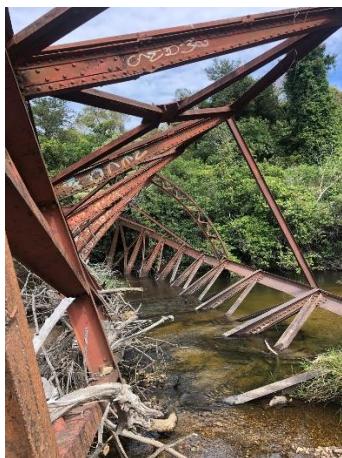
Figure 4 Partial view of the damaged bridge [4].

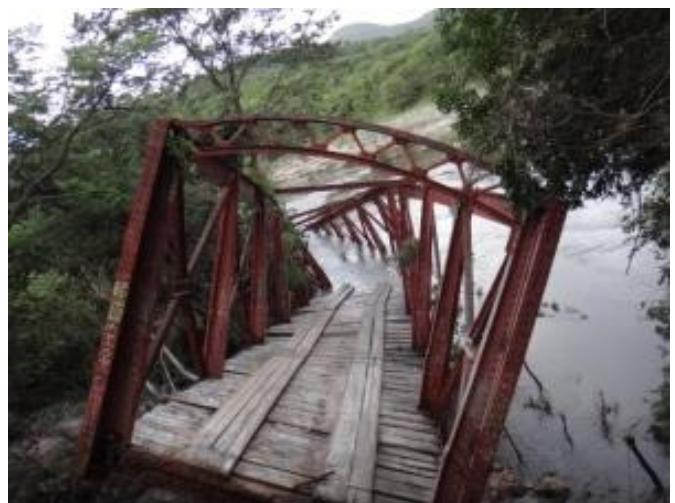
With the collapse of the bridge, there was a complete interruption of vehicle traffic, which required moving or imposing a diversion of 40 km. One of the bridge entrances after the incident is shown in Fig. 5. It is estimated that about 130 people (students, residents and employees of the power plant) used the bridge daily to access rural communities and Serra do Cipó district and were directly affected by the incident. Also, it is estimated that 70 students of a school bus route and tourists were affected as well, about 150 people weekly. According to representatives of the City Hall there were no records of people injured, displaced or homeless due to the incident [2].

Figure 5 Bridge entrance after the incident [5].
