*Special Issue: Rural Constructions*

*Scientific Paper*

## LOW-COST TIMBER BRIDGES FOR RURAL AREAS: A FIELD SURVEY AND RECOMMENDATIONS OF INTEREST

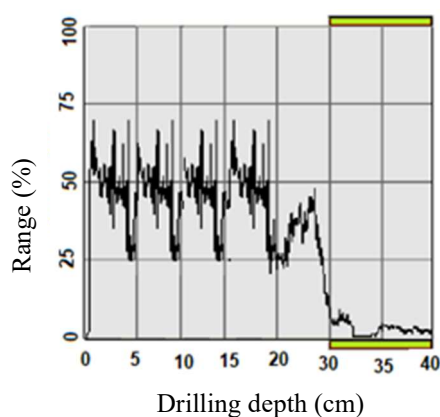
(a) Average resistance to drilling in the section between 0 and 5 cm and free section of the drill without resistance to drilling between 30 cm and 40 cm.

FIGURE 4. Controlled drilling of beams on Bridge 09 with the Resistograph.

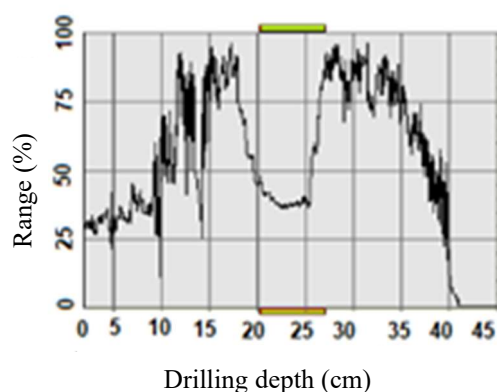
(b) Drop in resistance in the section between 20 cm and 26 cm, indicating the natural variability of the timber's resistance to drilling.

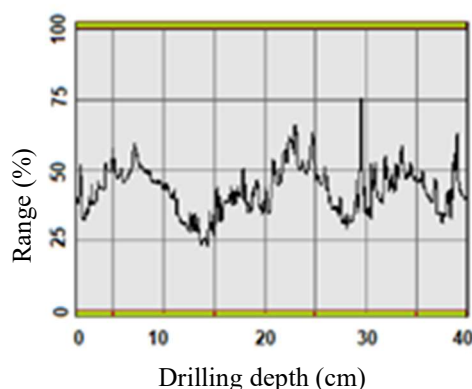
(c) Natural variation in drilling without identifying the presence of defects in the wood.

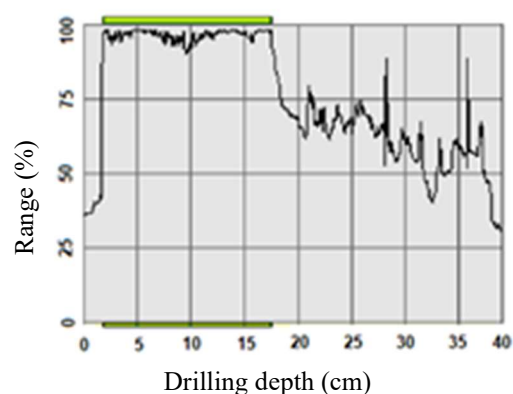
(d) High initial drilling resistance in the section between 2.5 cm and 17 cm with reduced resistance in the section between 17 cm and 40 cm.

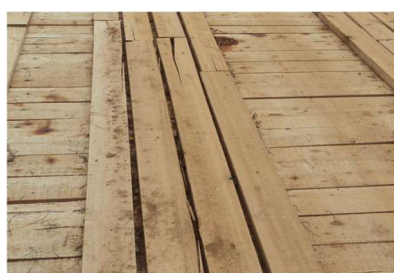
Absence of preservative treatment (A)

A – Preservative treatment with chromated copper arsenate (CCA), chromated copper borate (CCB), or creosote was not observed in the analyzed bridges. In Brazil, timber treatment against biological agents is not common. Some hardwood species, which have high resistance, may suffer deterioration in the sapwood region, which is more porous and susceptible to insect attack.

All timber parts used in bridges must be treated with preservatives and metal parts protected against corrosion.

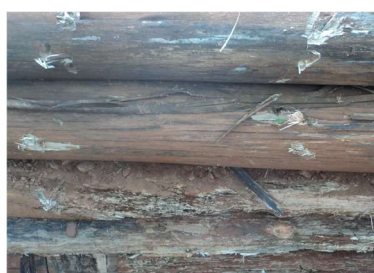
Attack by fungi and insects and signs of rot (B)

B – Only bridge number 07 showed no signs of rot or attack by fungi and insects, as it was recently renovated. However, it also showed no signs of preservative treatment, which means that it may face the same problems within a few years.

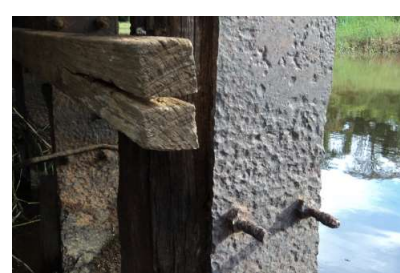
Use of metal connections without galvanization (C)

C – None of the analyzed bridges had galvanized metal elements. In Brazil, it is common to fix the timber elements of bridges with nails (25 x 72, i.e., 7 mm in diameter x 165.60 mm in length), clamps, and metal sheets without anti-oxidation treatment.

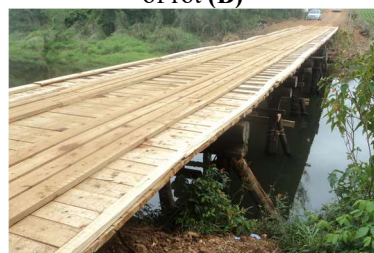
Absence of guardrails and wheel guards on the deck (E)

E – None of the analyzed bridges had wheel guards or guardrails. This configuration increases the insecurity of users

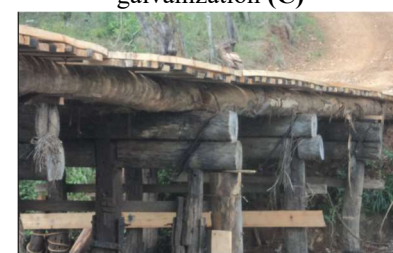
Inadequate transverse bracing (F)

F – Most bridges had deficient bracing systems.

A suitable bracing system should be used, and periodic maintenance should be carried out every 5 years.
