# Non-potable water systems: a sustainable solution or a risk to users?

**C.P. Castilho (1), L.H. Oliveira (2)**

(1) (2) Department of Construction Engineering of Escola Politécnica, University of São Paulo, Brazil

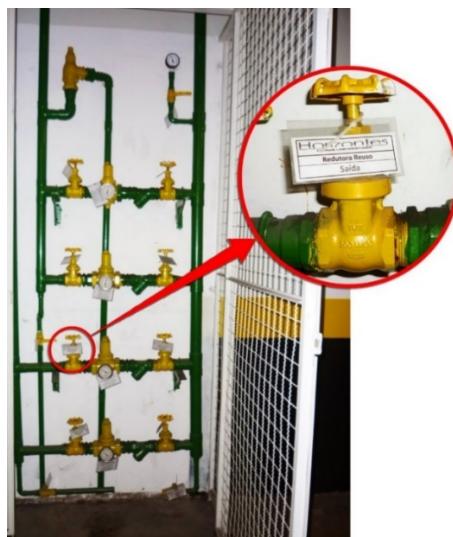
Regarding pipe identification, there is not a different color for the NPWS. Green stretches of non-potable water pipes were observed, the same color as that used for drinking water pipes, as illustrated in Figure 3. Pipes of different colors were used, without identification of the type of water they convey, with a risk of cross-connection in future maintenance or system changes.

**Figure 3 Pressure reducing station of non-potable water with the same color as that of the drinking water pipes**

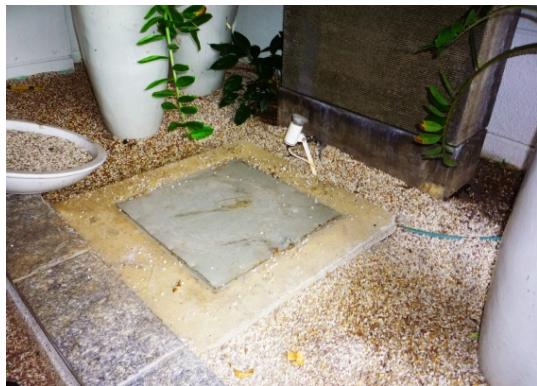
This is a condominium with four 22-storey buildings, 264 flats, and 898 inhabitants. The original design did not provide a non-potable water system for the building. The users decided to implement a system to make use of rainwater in order to reduce drinking water consumption. In addition to the rainwater collected from roofs and floors, water from washing the filters of the pool is also used as a source of NPWS supply, owing to an understanding that the chlorine present in this water helps disinfect the stored effluent. Non-potable water does not receive any kind of treatment, and it is only used to wash the floors of communal areas. There is no pipe conveying non-potable water from the reservoir to the points of use. A pump and a hose were installed in this reservoir. The floors are washed with this hose, using non-potable water pressurized directly from a pump. When the reservoir cover (Figure 4) was open for inspection, plastic packaging waste was found in the water, as can be seen in Figure 5.

**Figure 4 Access cover of the non-potable water reservoir**

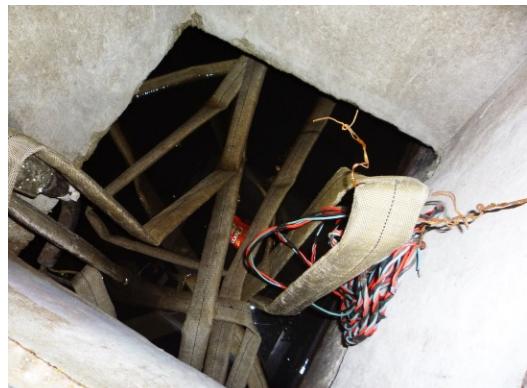
**Figure 5 Inside the non-potable water reservoir**

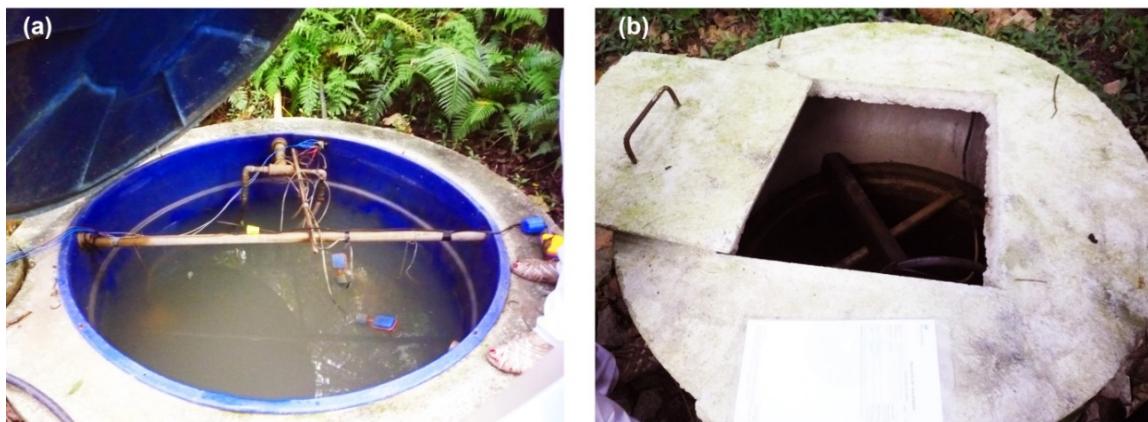
The treatment system used is the physicochemical and biological type and the addition of chlorine to non-potable water is made manually by a condominium employee weekly. The water collected from the well does not pass through any treatment and is conducted directly to the undergrounded tank of non-potable water. The water in the undergrounded tank and in the well has a cloudy appearance, as can be seen in Figure 6.

**Figure 6 Aspect of the water in theundergrounded tank (a) and in the well(b)**

The condominium does not routinely control non-drinking water quality, but in early 2015, the residents noted that the non-potable water was of an unpleasant color and odor, causing stains on water closets. For this reason, water samples from the non-potable-water roof tank and from the well were collected and sent for laboratory analysis.

The sample from the non-potable-water roof tank showed non-compliance for the following parameters: total dissolved solids and thermotolerant coliform bacilli. The well water sample showed non-compliance for: color, pH, turbidity, total coliform bacilli, *Escherichia coli*, and heterotrophic bacteria count.

Despite the non-compliance instances identified in laboratory reports, the NPWS-R was not disabled. For security reasons, the condominium decided no longer to use non-potable water in the irrigation of the collective vegetable garden.

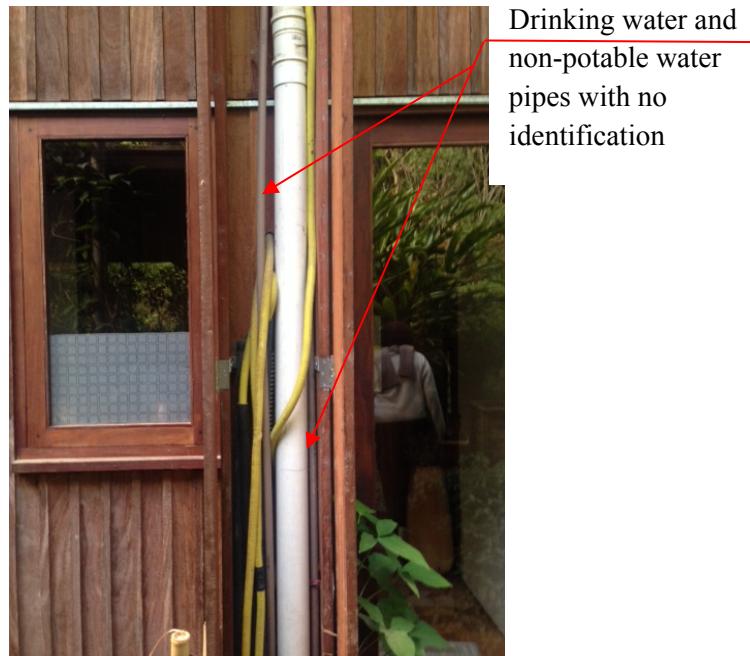
The NPWS-R piping does not show differentiation by color or identification of any sort. In addition, the same type of pipe was used for the distribution of both drinking water and non-potable water. Figure 7 shows the pipes inside the shaft of one of the houses.

**Figure 7 Inside a shaft with no identification that differentiates the pipe systems**
