# Natural weathering rack for evaluating solar reflectance degradation of exterior building coatings

Conference Paper · December 2023

Ana Carolina, Hidalgo-Araujo<sup>1</sup>, Kelen Almeida, Dornelles<sup>2</sup>

<sup>1,2</sup>Institute of Architecture and Urbanism of University of São Paulo, São Carlos, Brazil

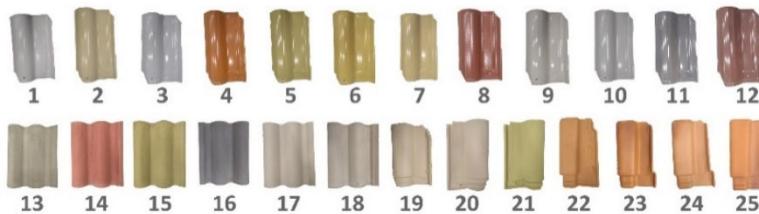
Figure 1. Selected tiles. 1 to 12 - glazed ceramics; 13 to 18 – concrete; and 19 to 25 - pigmented or conventional ceramic.

The 25 selected tiles were purchased from local building material stores (São Carlos, SP, BR) and divided into 3 groups based on their raw materials (Figure 1. and Table 1). The colors of the glazed ceramic tiles are fixed by an acrylic resin after firing, while concrete tiles are pigmented directly in the mass and colored as a whole and not only on the surface. The colored ceramic tiles (19, 20 and 21) are pigmented by a layer of powder paint obtained by heating at high temperatures. Ceramic tiles 23 and 24 are the only ones that have had a transparent resin applied to their surface for waterproofing, and tiles 22 and 25 have no differentiated finish. Among all samples, only tiles 1 and 9 meet the cool roof criteria (Table 2), with an initial solar reflectance (SR) higher than 0.65 (CASINI, 2016).

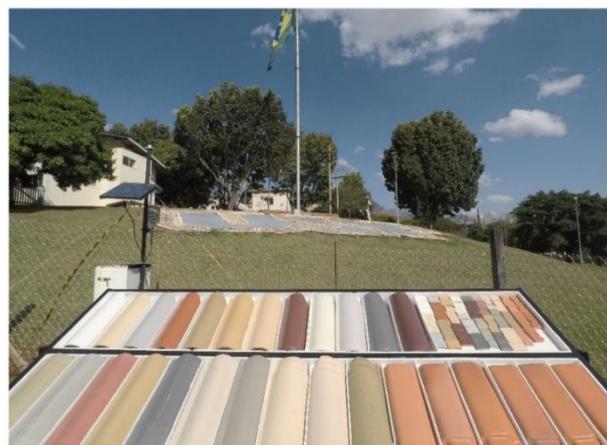
Figure 3. Weathering rack finished and in operation.

The structure was made of galvanized steel tubes coated with synthetic enamel paint to prevent metal oxidation. OSB type wood panels were fixed to the galvanized steel to support the polystyrene panels (15mm) in contact with the tiles. The adaptable locking system (0° - 80°) allows reusability for different material analyses (Araujo and Dornelles, 2022). After assembly, circular cuts facilitate rainwater drainage and allow the passage of the thermal monitoring data system. Designed not only for sample exposure, but also for continuous surface temperature monitoring of the tiles, a rail was positioned on the back of the system near the OSB panel to guide wires, with a protective box for thermocouples. Construction was completed and operations began in July 2019 (Figure 3).

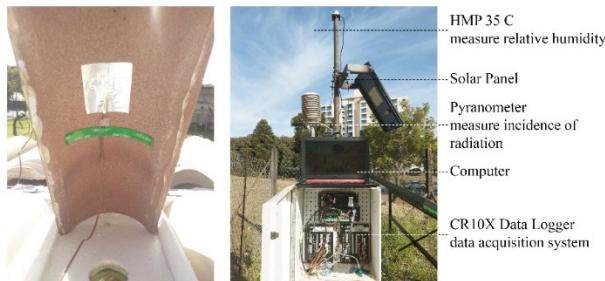
Figure 4. a) Thermocouple position b) Supplementary measuring system and rack feed.

Undersurface temperatures of the tiles on the weathering rack were continuously monitored to assess the effect of solar reflectance degradation on heat absorption. Monitoring was performed using Testo S30-T1 infrared thermometers with a resolution of 0.1°C and T-type thermocouple sensors (copper-constantan; 0.51 mm; Teflon/Teflon insulation; ANSI standard) glued to the underside of the samples. Contact between the thermocouple and the underside of the tile was made through one of the circular openings, ensuring weather protection and data integrity. Thermal paste and low-emissivity metal adhesive tape were used to attach the thermocouple to the underside of the sample to minimize external disturbances to data monitoring (Figure 4a).

The data storage unit contains a UPS battery (12V, 7Ah), a CR10X data logger for data acquisition and storage, and two multiplexers that amplify the data logger outputs for simultaneous sample measurements. The fiberglass unit is painted white to reduce the effect of external solar radiation on the experiment. Power for the data acquisition system comes from a 21-volt solar panel that powers the temperature monitor. Two additional instruments, measuring relative humidity (HMP 35C, Vaisala) and irradiance (Pyranometer SP Lite, Kipp & Zonen), complement the aging station assembly. These are connected to the data acquisition system along with the 25 thermocouples on the exposed tiles. The data logger, programmed using PC400 software (Campbell), records tile temperature and local climate data every minute and calculates averages every 30 minutes (Figure 4b).
