# Landslides and Engineered Slopes. Experience, Theory and Practice

# Debris flows occurrence by intense rains at Itaoca city, São Paulo, Brazil: Field observations

**ABSTRACT:** In recent years an increase in the occurrence of debris flows has been observed in various regions of Brazil. These mass movements can be characterized by the expressive volume of material mobilized during a relative short period of time, long distances of travelling, high velocity and high transport capacity. On January 13, 2014 an extreme precipitation event produced landslides, debris flows and flash floods in two basins. The study area is located in the “Guarda-Mão” watershed, at Itaoca municipality, which is about 348 km southern of São Paulo city. The basin is lithologically very homogeneous, because the bedrock consists of granitic rocks. The debris flow and flash floods occurred during convective summer storms, with rain intensities of 210 mm in two hours. The damage caused by the occurrence of debris flow included destruction of plantations, houses, bridges, roads, two missing people and 25 deaths.

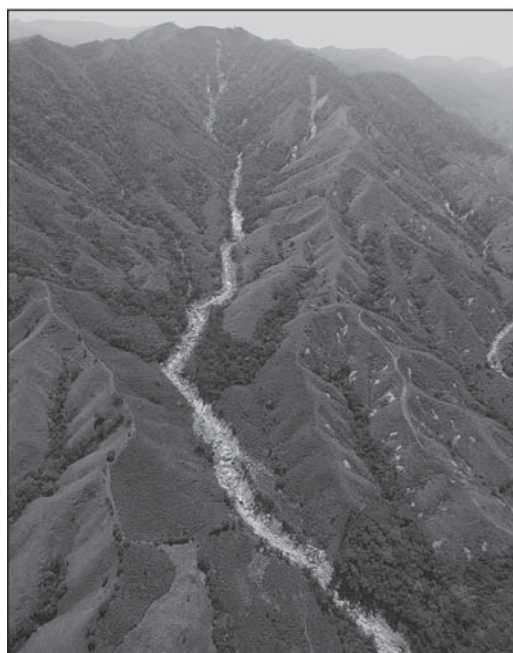
Figure 2. Panoramic view of Guarda-Mão creek. Observe the landslides scars and the severe river bank erosion.

Figure 2 shows the rugged relief configuration, landslides scars and severe river bank erosion in Guarda-Mão creek.

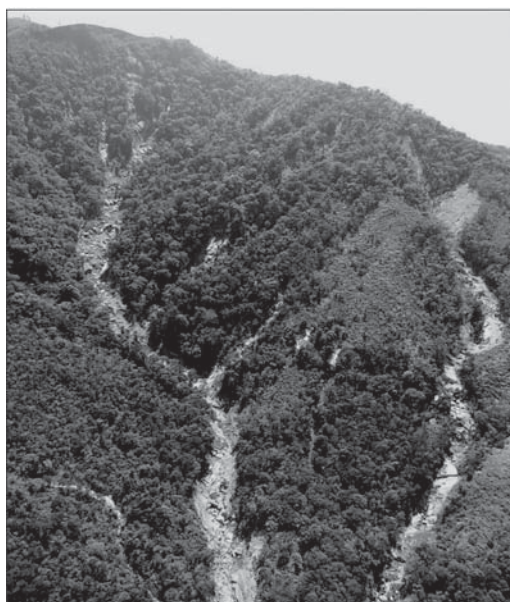
Figure 5. View from the upper portion of the slopes of the Guarda-Mão stream basin. In this sector, predominated soil and rock slides with variable size and shape. Observe the vegetation cover present in this upper portion of the slope and the materials present in the streambed.

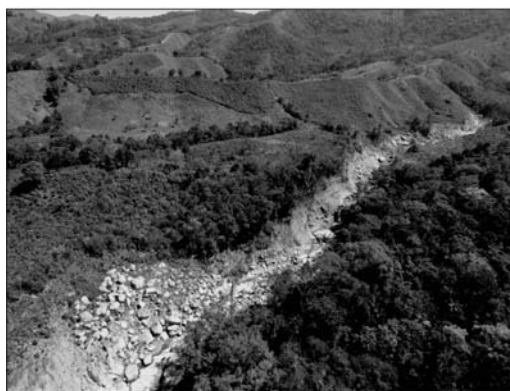
Figure 6. Overview of the Guarda-Mão creek basin, especially the stretch where there was intense bank and stream bed erosion.

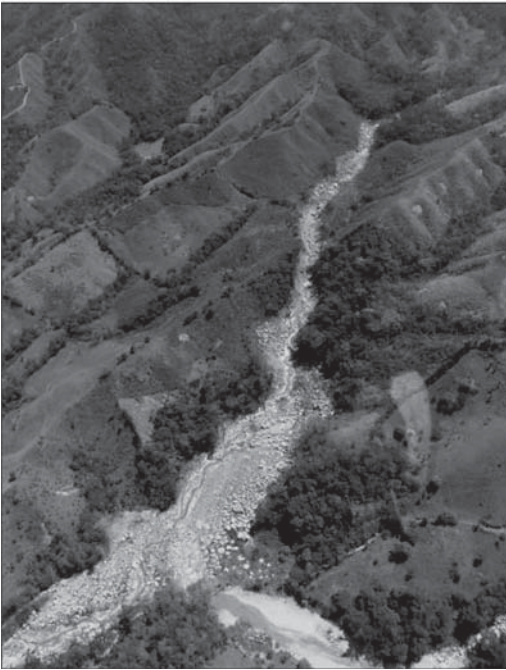
Figure 9. Aerial view photograph of December, 2014: View from downstream of the T2 section, highlighting the erosion and deposition areas along the channel under confined flow conditions.

Figures 9 and 10 show images of fly-over in the Guarda-Mão Basin (December, 2014), highlighting the different sections with a predominance of ero-

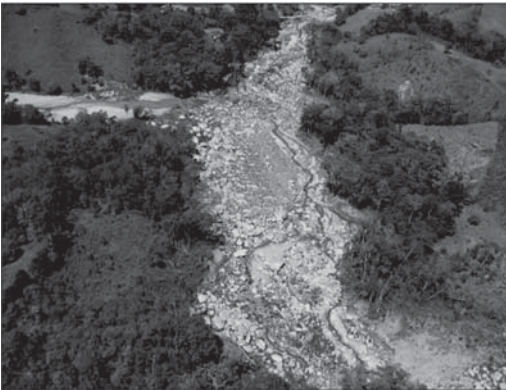
Figure 10. Aerial View of the transition area T2 / T3, from upstream: notice number and size of materials deposited in the stretch. The drainage in this part had a width of about 2 m before the passage of the flow.

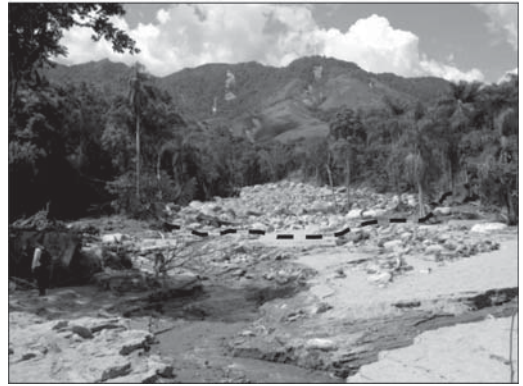
Figure 11. General view of the stretch intensely affected by the debris flow. This is the limit between the boulders and sandy deposition.

Figures 11–16 illustrate the social and environmental impacts, caused in the area: a total of

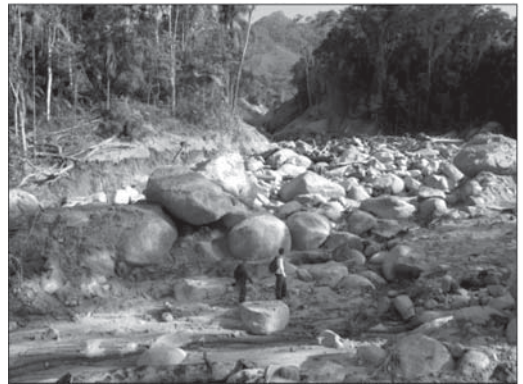
Figure 12. Debris flow deposits in a stretch where predominates sediments of boulders (> 2 m) proportions.

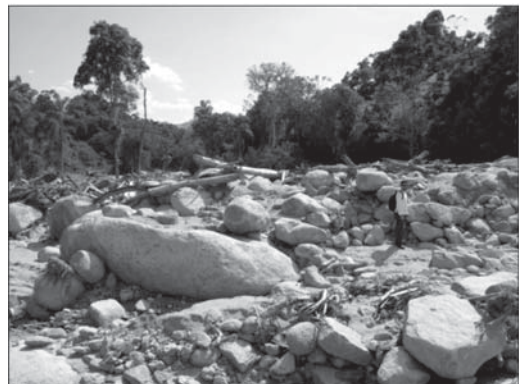
Figure 13. Debris flow deposit. The frontal portion is composed of big rock blocks, imbricated and orientated according to the main flow direction.

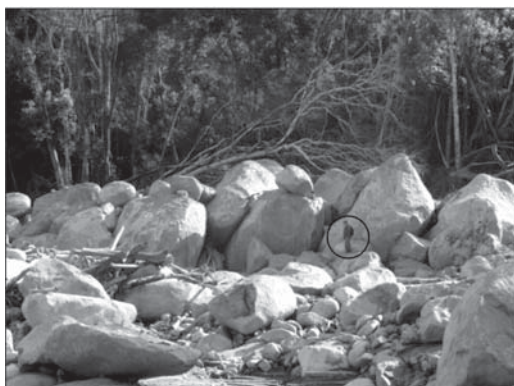
Figure 15. Intense deposition and imbrication of big rock blocks, at the left Guarda-Mão river bank. There was a home in this place.

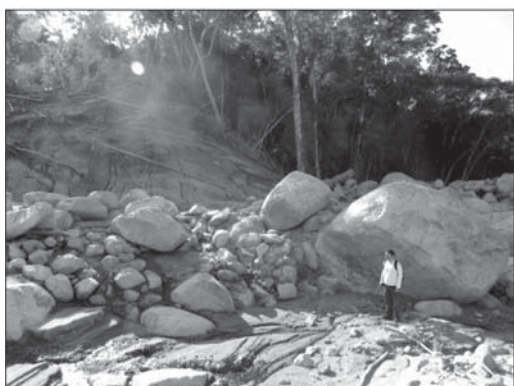
Figure 16. View of the levee formed in the left Guarda-Mão river bank.
