# Method for Damage Detection of CFRP Plates Using Lamb Waves and Digital Signal Processing Techniques <sup>†</sup>

**Abstract:** The identification and severity of structural damages in carbon fiber reinforced polymer (CFRP), especially in the early stage, is critical in structural health monitoring (SHM) of composite materials. Among several approaches used to accomplish this goal, ultrasound inspection using Lamb waves has been taking place within non-destructive testing (NDT) methods. Likewise, the use of digital signal processing techniques for structural damage diagnosis has become popular due to the fact that it provides relevant information through feature extraction. In this context, this paper presents an alternative strategy based on the use of root mean square deviation (RMSD) and correlation coefficient deviation metric (CCDM) representative indices to extract the most sensitive information related to damage in CFRP plates through ultrasonic NDT signals in specific frequency ranges. In the experimental analysis, CFRP coupons were subjected to two types of damages: cracking and delamination. The signals, generated by piezoelectric transducers attached to the host struc

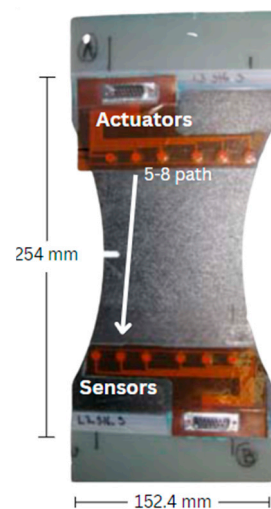
The composite samples were prepared using a  $254 \times 152.4$  mm Torayca T700G unidirectional prepreg composite. The samples have a dogbone geometry and a  $19.3 \times 5.08$  mm notch, as illustrated in Figure 1, to provide stress concentration.

For monitoring the fatigue test damage, two sets were used, with six SMART Layer<sup>®</sup> piezoelectric zirconate titanate (PZT) transducers each, developed by Acellent Technologies Inc. (Sunnyvale, CA, USA), arranged in a pitch-catch configuration. This configuration allows monitoring the Lamb wave propagation in 36 different trajectories.

**Figure 1.** CFRP coupon prepared for fatigue testing. Adapted from [3].

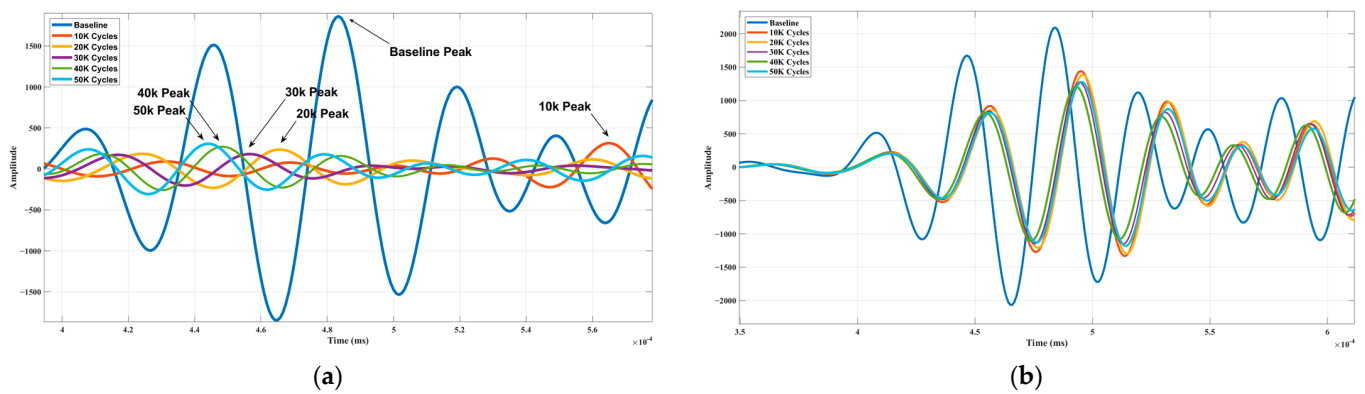
Initially, a time domain analysis was performed for the signal acquired by the transducer illustrated in Figure 2, in which it is possible to observe the behavior patterns for the different classes of damage present in the sample. Figure 2a shows the signal pattern with delamination in the structure, where it is possible to observe a reduction in signal amplitude compared to the baseline condition, and also the displacement of the signal peaks, caused by the damage progression in the sample. The signals from trajectory 3–10, shown in Figure 2b, where the only damage is due to the micro-cracking, have a more regular comportment, with the signal amplitude attenuation and displacement to the opposite direction presented in the trajectory with delamination.

**Figure 2.** Time-domain signals for the (a) 5–10 and (b) 3–8 path.

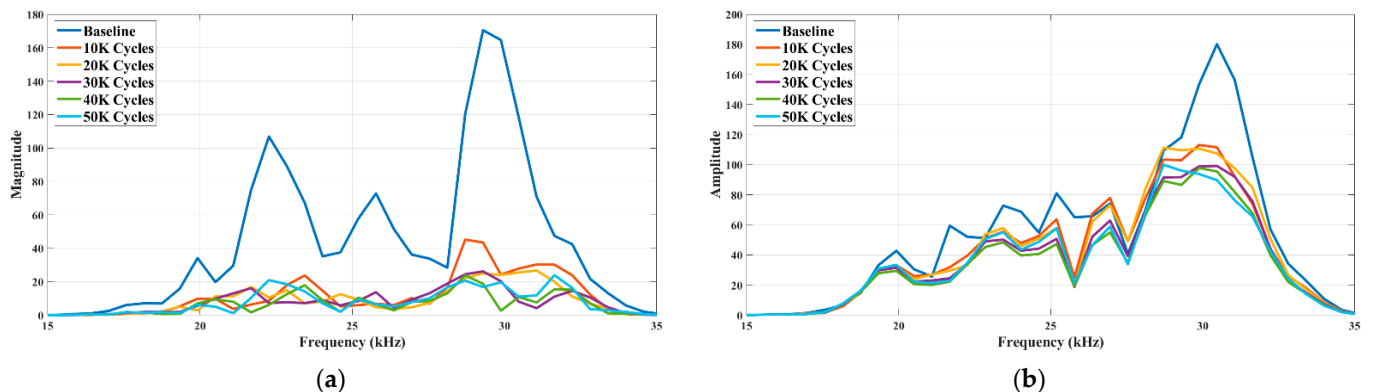
By using the Fast Fourier Transform (FFT), the frequency spectrum was analyzed. Figure 3 shows the spectral behavior of the trajectory with delamination (Figure 3a), where a significant reduction in the magnitude as the delamination progresses is evident, as well as the main bands where the damage happens. As observed previously, path 3–10 (Figure 3b) presents a magnitude reduction characteristic, but not as pronounced as the one caused by delamination, as the fissures occur in its matrix. With this analysis, in the next step, damage metrics will be calculated to identify the frequency bands most susceptible to damage.

**Figure 3.** Frequency-domain signal for the (a) 5–10 and (b) 3–8 path.

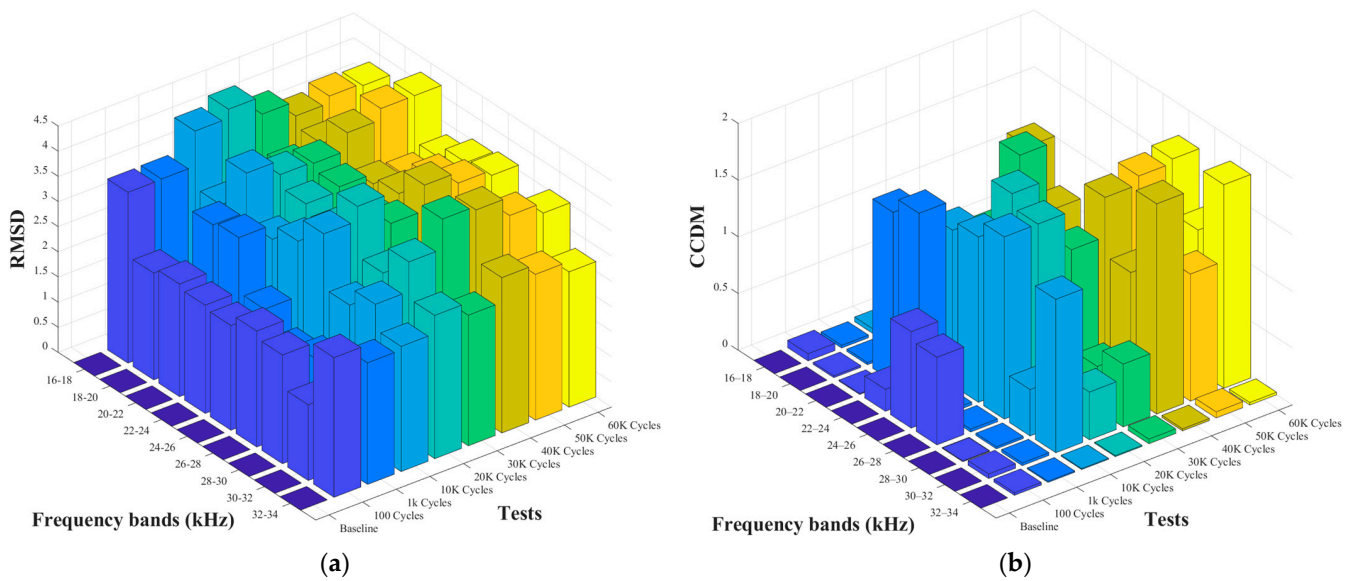
To contribute to the analysis of the damage present in this data set, the RMSD and CCDM indexes were calculated for the two damage classifications. These indices allow a comparison of the signals obtained with samples in pristine conditions (baseline), with the signals that may present some kind of damage. For both types of damage were adopted a 16 to 34 kHz band, with a 2 kHz range, using the FFT magnitude values. Figure 4 shows the RMSD (Figure 4a) and CCDM (Figure 4b) calculated with the delamination signal. The results indicate that frequency bands from 20 to 22 kHz (RMSD) and 28 to 30 kHz (CCDM) are more sensitive for the characterization of the delamination severity suffered by the coupon.

**Figure 4.** Damage indexes: (a) RMSD and (b) CCDM index for the 5–8 path with delamination.

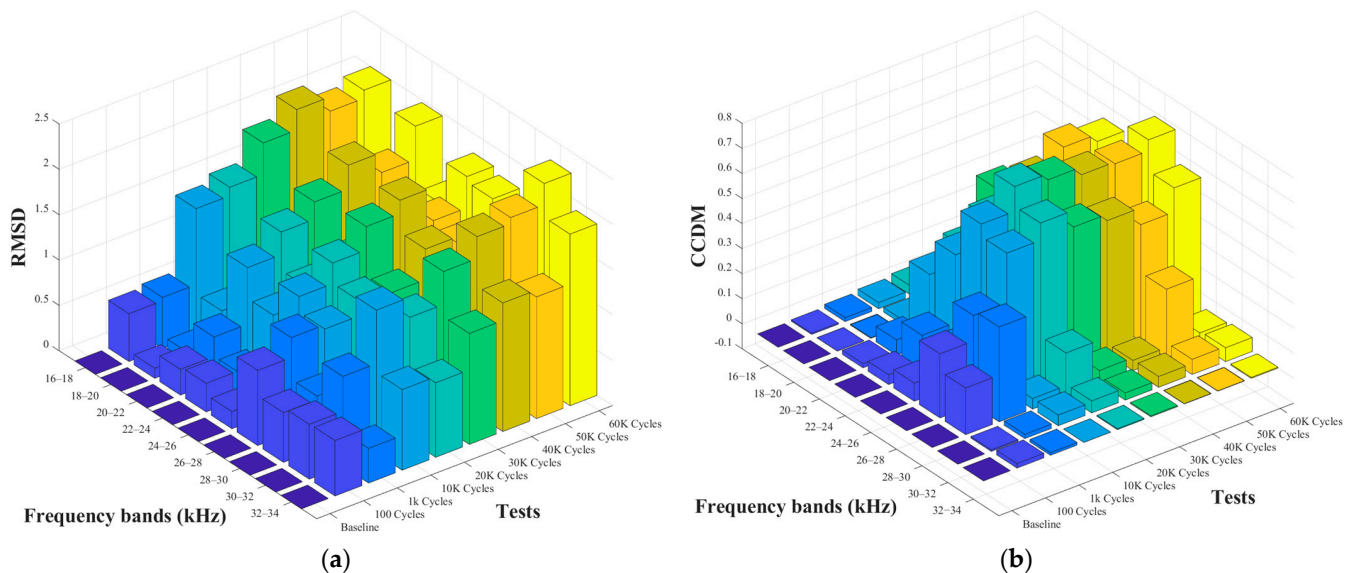
Using the same parameters, the indices were calculated for the trajectory with fissures. Figure 5 presents the RMSD (Figure 5a) and CCDM (Figure 5b) indices calculated for the delamination signal. This analysis evidences the capacity of these metrics in detecting the fissure progression in several stages of the sample's lifetime, particularly in the bands from 30 to 32 kHz for the RMSD metric and 24 to 26 kHz for the CCDM metric, which is a useful solution when applied in industrial engineering projects. The solution is also notable for its simplicity and low computational cost since the most representative frequency bands for damage are below 40 kHz.

**Figure 5.** Damage indexes: (a) RMSD and (b) CCDM index for the 3–10 path with microcracks.
