# Community based landslide risk management: collaborative monitoring experience - Vila Nova Esperança

## Abstract

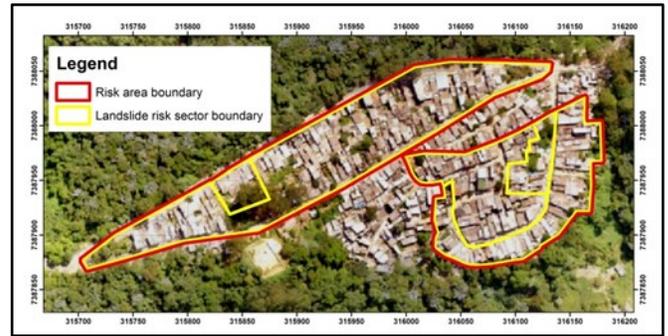
Figure 3. Landslide risk map.

Landslide risk maps were made by IPT in 2006 and 2010 (Figure 3). In Vila Nova Esperança high and very high sectors were mapped (Figure 3).

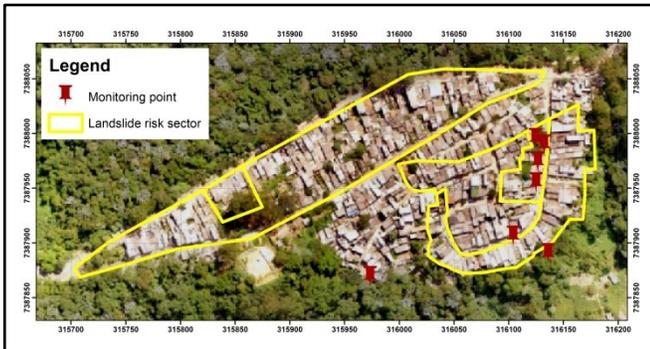
Figure 4. Monitoring points in Vila Nova Esperança.

It was select 7 monitoring points and 5 volunteer residents/families that live close to these points. The residents were trained to obtain the weekly photos for monitoring. Afterwards, they were trained to analyze the photos and identify the changes in the points and identify the signs prior to a rupture.

Figure 4 shows the points of monitoring and a brief description of them were in Table 1.

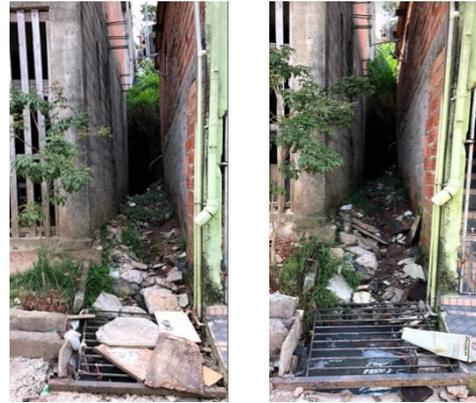
Figure 6. Garbage and construction waste disposal in the lane.

The monitoring point of the lane allows an analysis of the garbage and construction waste disposal in the lane. The construction waste hinders the function of rainwater drainage system. (Figure 6).

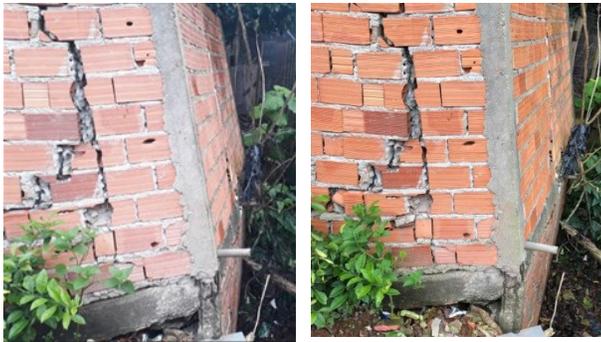
Figure 5. Crak in the wall border.

The point is in a very high risk area, since the dwellings were built on the landfill slope, the resident, due to his social vulnerability, was not able to continue the monitoring.

Figure 5 shows the photographs of the monitoring. The visual comparison between them allows us to conclude that the crack in the wall of the neighboring property did not evolve from one week to another.

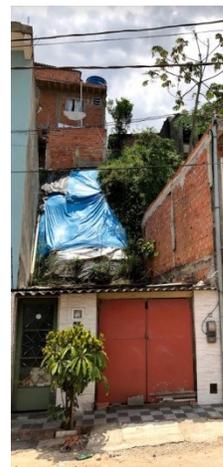
Figure 7. Plastic canvas in an old landslide.

Placing plastic canvas on a cutting slope after a rupture is a constant action in Brazil and cannot be different in Vila Nova Esperança. So at this point we can infer that a landslide has already occurred in the past (Figure 7).

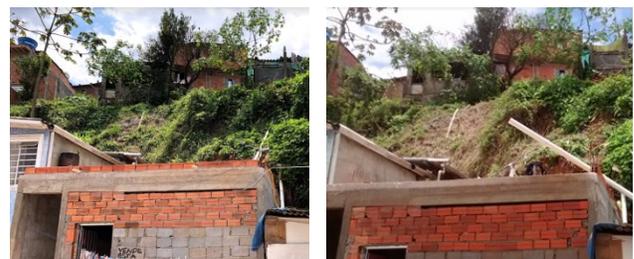
Figure 8. Cut slope behind the house.

Another important observation point is the slope behind the house. The vegetation did not allow identifying a broken pipe throwing sewer in the cut slope which culminated in the slope rupture.

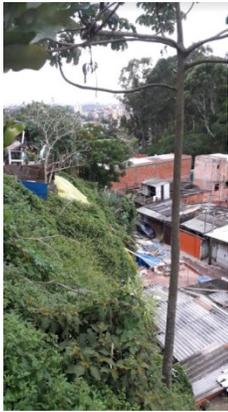
Figure 9. Slope view.

This point was located at the top of the cut slope. During the monitoring time any changes or indications of movement was observed (Figure 9).

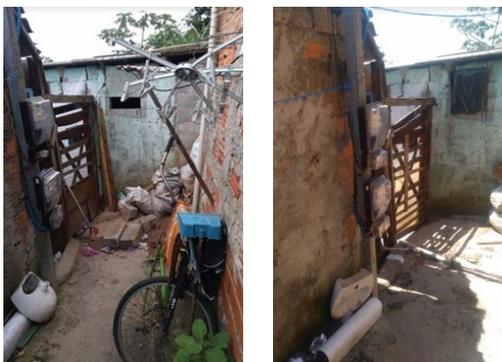
Figure 10. Garbage in the top of the slope.

This point was intended to monitor the release of disposal water and sewage in the top of the slope. Note that the garbage was cleaned (Figure 10).

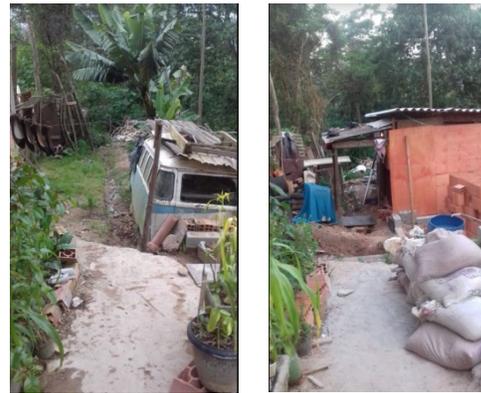
Figure 11. New house built in one month.

This point is located at the area of expansion of the community inside the forest. In the photos sent it is possible to notice that within one month a new house was built where a Kombi was (Figure 11).
