D9 - Field evaluation of water consumption and drainage system performance when 6.8Lpf toilets were replaced by 4.8Lpf toilets

VALENCIO, Isabella P. (1), GONCALVES, Orestes M. (2)

(1) Department of Civil Engineering, University of São Paulo, Brazil

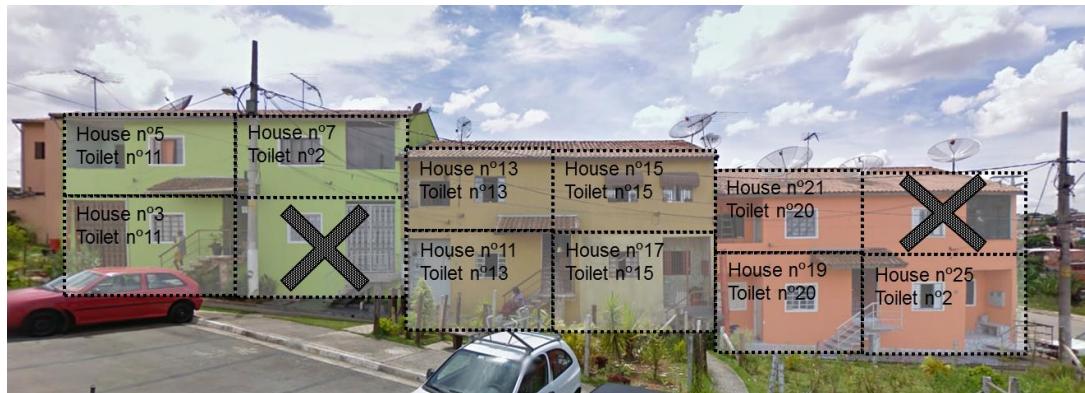
Figure 17 – Scheme of the houses monitored

Firstly, the houses to be monitored were selected. The chosen houses consist of twelve houses (six houses on the ground floor and six on the first floor), according to Figure 17, with a frontal scheme of the units. Although the housing development has twelve houses, the residents of houses 9 and 23 did not allow monitoring. Therefore, the field study was conducted with ten houses.

The five toilets considered to have been approved in the laboratory study, were installed in the field. As the residents of ten houses accepted to participate in the study, each toilet was installed in two houses. As far as possible, the same model was installed on the floor unit and on the first floor, as shown in Figure 17.
