Article

Potential Transformation of Contaminated Areas into Public Parks: Evidence from São Paulo, Brazil

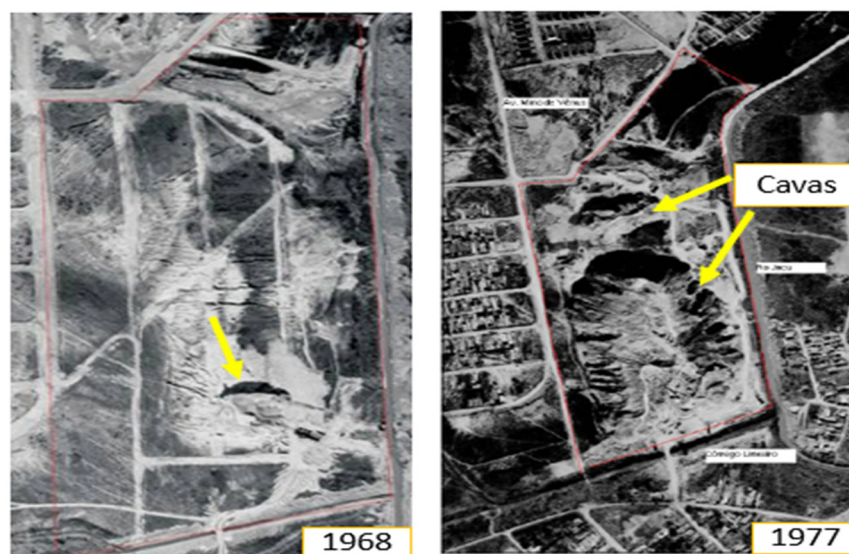
Figure 3. Pit formation in 1968 and 1977. Municipal Park Jardim Primavera [18].

Around 1979, the city of São Paulo was pressured by the local population to ground the pits that began to receive urban solid waste at the site. In an immediate response to the population, the smaller pit was grounded with soil from the leveling of the land, and the larger pit continued to receive construction residues (rubble), but there was no control for its disposal. The site also received other types of waste from 1979 to 1988 [18,21]. Urban solid waste was arranged randomly on the larger mining pit in precarious operating

conditions and without technical measures for soil and groundwater protection, turning it into a dump [22].

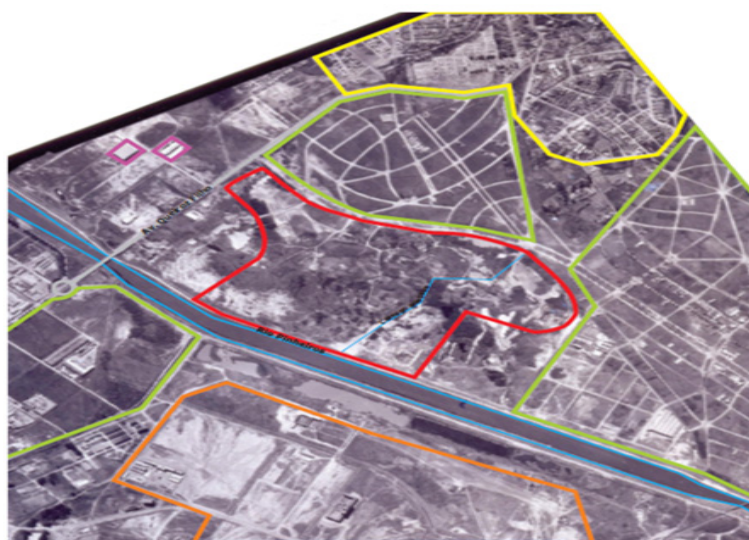
Figure 4. Villa-Lobos site. Occupation of the area and neighborhood in 1958. Colors: Red: Villa-Lobos Park Area; Brown: Earth movement; Green: green area/allotment; Blue: Body of water; Yellow: residences; Purple: industries; Orange: University of São Paulo [19].

Villa-Lobos State Park is already finished and in use. It belongs to the government of the state of São Paulo. In the area of the park, located in an old floodplain of the Pinheiros River, the occupation began in 1958, where it presented grassy vegetation, some paths of earthmoving and the Boaçava stream (Figure 4).

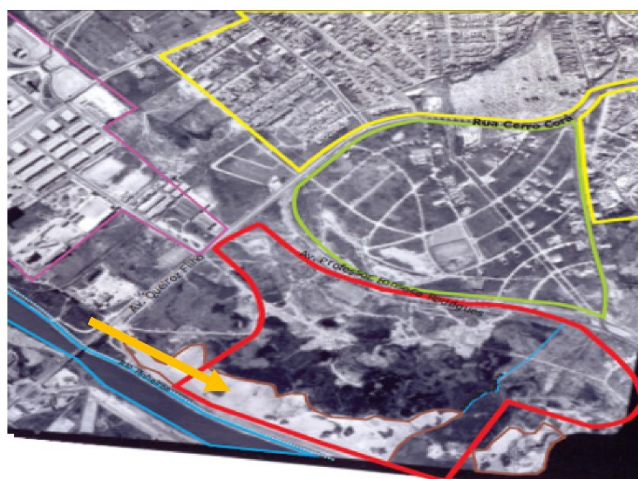
Figure 5. Villa-Lobos site. Earth movement in the south part of the area in 1968 [19].

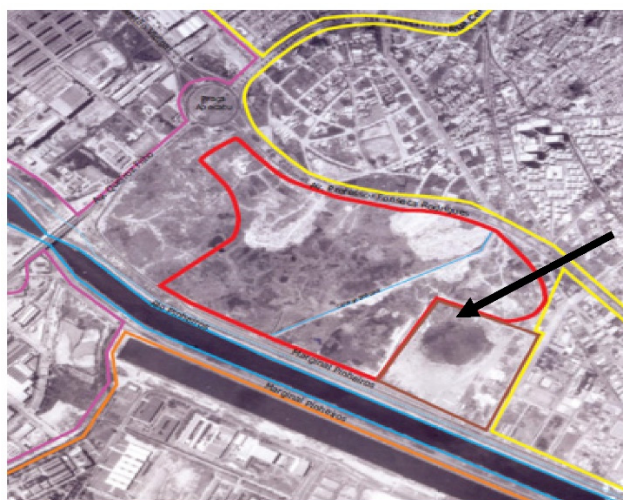
Figure 6. Villa-Lobos. Disposal of dredged material next to the old sand mine in 1977 [19].

During this period, near the site where the administration of the park operates nowadays, an area was identified that received metal materials for recycling, apparently scrap from underground storage tanks. The surroundings at that time had the same characteristics as in 1968, but with increased occupation (Figure 6).

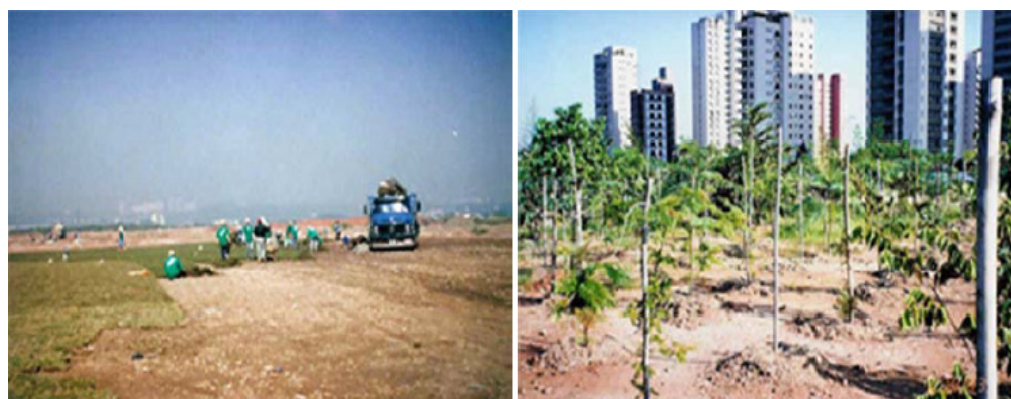
Figure 7. Building of Villa-Lobos State Park in 1989 [24].

In 1989, the Villa-Lobos State Park began to be deployed, starting with earthworks, Figure 7.

The entire area of the park received a clean soil cover with known origin, in variable layers to level the existing elevations, preventing direct contact with the deposited material and the flow of rainwater (Figure 7). The Boaçava stream, which passed through the area, was channeled. All the residue was kept in the ground. After earthmoving, the park was 6 m taller than the avenue next to it. In this period, families living on the site were removed, 500,000 m³ of rubble more than 1 m in diameter was removed, and 2 million m³ of rubble was moved.

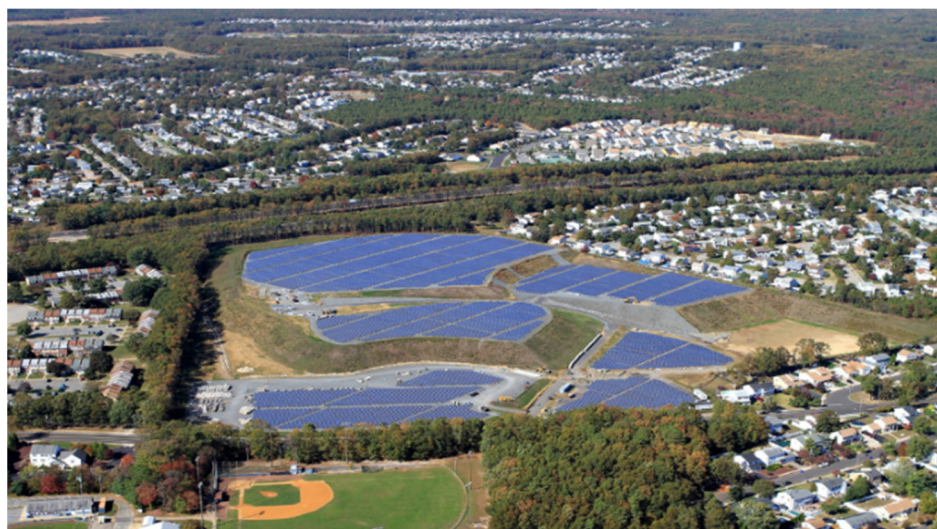
Figure 8. Brick Town landfill. Solar panel view [38].

Therefore, Brick Township decided to turn this former landfill into a solar power facility, providing electricity to the surrounding government buildings, residences and community parks, Figure 8.
