PROCEEDINGS OF THE EUROPEAN ROCK MECHANICS SYMPOSIUM (EUROCK) 2010  
LAUSANNE, SWITZERLAND, 15–18 JUNE 2010

# Rock Mechanics in Civil and Environmental Engineering

## The accident at the Pinheiros underground station of line 4 of São Paulo's metropolitan subway: A case of local geological conditions that led to an unforeseen geomechanical behaviour

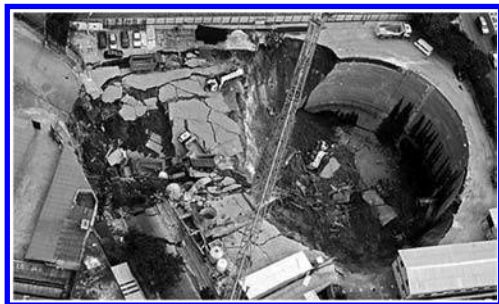
On January 12th 2007, at 14:00 p.m., a violent collapse took place and brusquely propagated itself, reaching the shaft, as seen the illustration below (Fig. 1).

Figure 1. Tunnel collapse reaching the shaft.

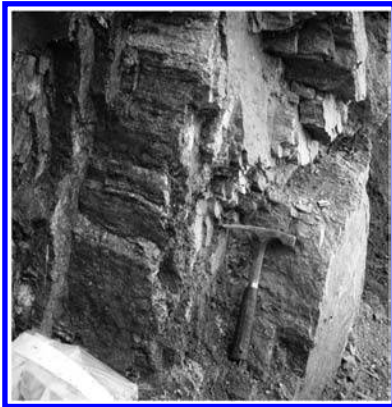
Figure 3. Open NW joints, altered walls, with filling.

The NW joints (Fig. 3), which free the blocks laterally for the formation of the wedge, generally exhibit millimetric openings, of a flat and undulated, smooth and coarse surface, with oxidation, alteration, and locally with clay coating. In some of these joints the presence friction slickenside within the argillaceous filling material was observed.
