# Influence of voxel size on dentinal microcrack detection by micro-CT after root canal preparation

**Abstract:** The aim of this study was to assess the influence of micro-computed tomography (micro-CT) voxel size on dentinal microcrack detection after root canal preparation using rotary heat-treated nickel-titanium files. Curved mesial root canals ( $n = 24$ ) of mandibular molars were prepared using ProDesign Logic 30/.05 (PDL) or HyFlex EDM 25/.08 (HEDM). The specimens were scanned by micro-CT at 5  $\mu\text{m}$  voxel size before and after root canal preparation. The percentage of microcracks was evaluated in images at 5, 10 and 20  $\mu\text{m}$  voxel size, by two examiners at two moments. The Kappa and McNemar tests ( $\alpha = 0.05$ ) were used. The percentage of dentinal microcracks was similar before and after PDL and HEDM preparations, at 10 and 20  $\mu\text{m}$  ( $p > 0.05$ ). HEDM showed a higher percentage of dentinal microcracks in the middle third at 5  $\mu\text{m}$  after preparation ( $p < 0.05$ ). The detection of dentinal microcracks before and after instrumentation using PDL was more accurate at 5  $\mu\text{m}$  than at 20  $\mu\text{m}$ , in all thirds

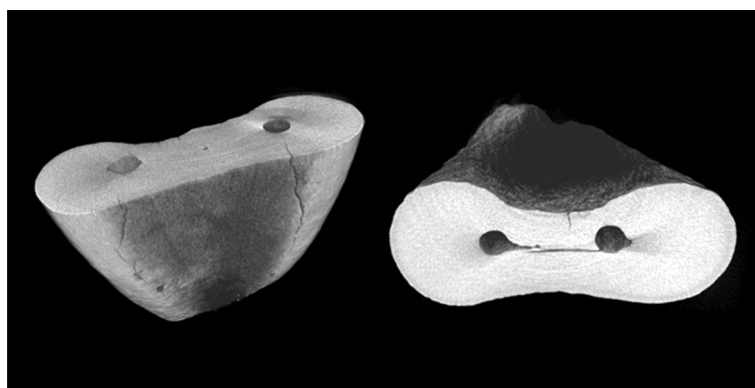
**Figure 1.** 3D reconstructions showing microcracks in the mesial roots of mandibular molars.

The analyses were performed in the middle and apical thirds of the roots, considering 3 mm for each third. The microcracks were evaluated by opening the cross-sectional images before and after instrumentation, and evaluating them at the same time. The analyses were performed in three voxel sizes, totaling 14,400 slices of cross-sectional images at 5 µm, 7,200 at 10 µm, and 3,660 at 20 µm, per third in each group. The images were then compared twice by two blinded examiners, at two different times. Microcracks were defined as lines or defects extending from inside the root canal to the dentin, or from the outer root surface into the dentin (Figure 1). The distribution of microcracks was expressed as a percentage of the total cross-sectional images.

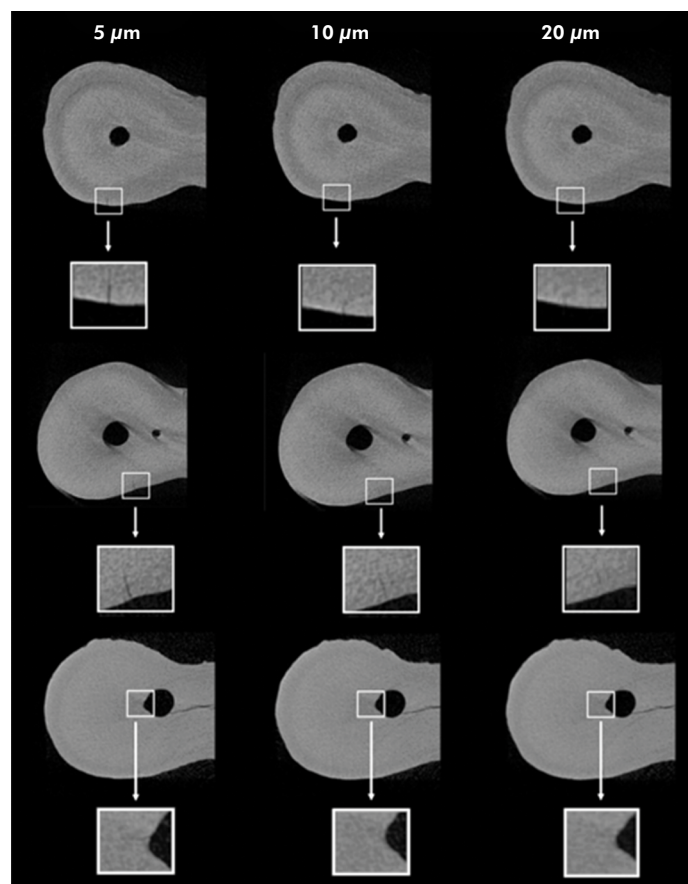
**Figure 2.** Representative cross-sectional micro-CT images showing a thinner continuity of microcracks based on different voxel sizes.

The kappa values were greater than 0.81 for all parameters assessed, thus confirming intraexaminer and extraexaminer agreement. The detection of dentinal microcracks in the PDL group, before and after instrumentation, was more accurate at 5  $\mu\text{m}$  than at 20  $\mu\text{m}$  in all thirds ( $p < 0.05$ ) (Table). Figure 2 shows a thinner continuity of microcracks based on different voxel sizes.

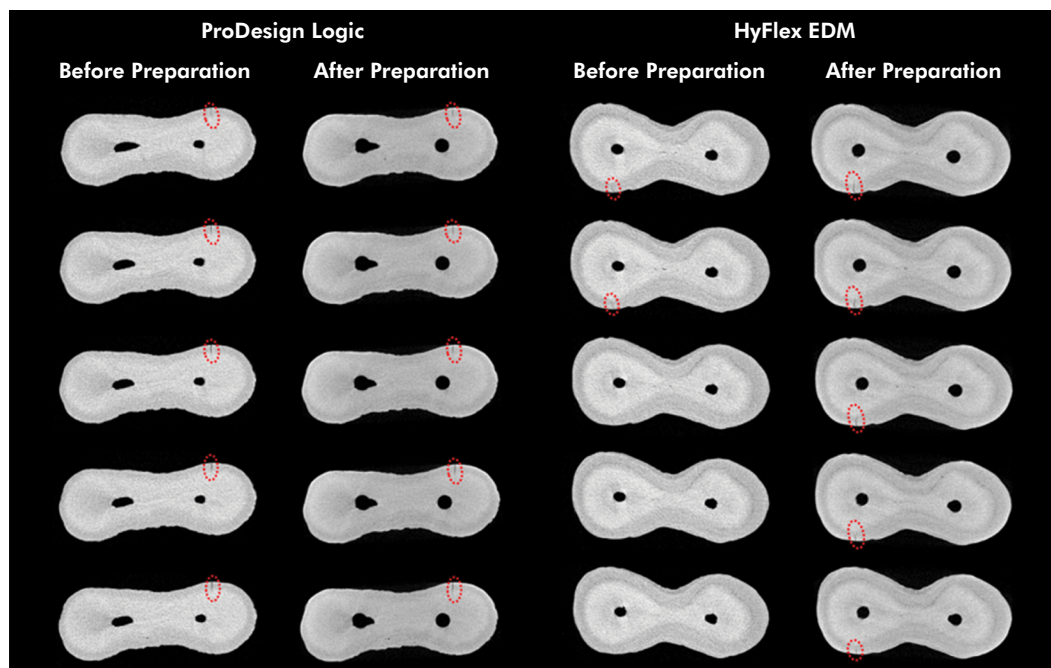
**Figure 3.** Representative cross-sectional micro-CT images, at 5  $\mu\text{m}$  voxel size, showing microcrack continuity with a 50  $\mu\text{m}$  interval between slices, before and after instrumentation with the ProDesign Logic and HyFlex EDM systems. Microcracks are circled in red.

No differences were observed in the apical third before or after instrumentation in any of the voxel sizes (5, 10 and 20  $\mu\text{m}$ ), in the HEDM group, ( $p > 0.05$ ). The comparison between before and after instrumentation with PDL and HEDM showed that the percentage of dentinal microcracks was similar for both groups at 10 and 20  $\mu\text{m}$  ( $p > 0.05$ ). However, the percentage of dentinal microcracks after instrumentation with HEDM was higher in the middle third at 5  $\mu\text{m}$  ( $p < 0.05$ ) (Table). Figure 3 shows cross-sectional images revealing microcracks before and after instrumentation with the PDL and HEDM systems.

The analyses at 10 and 20  $\mu\text{m}$  were similar regarding the presence of microcracks before and after the preparation with HEDM files. However, assessment at 5  $\mu\text{m}$  showed a higher percentage of microcracks in the middle third after instrumentation, partially rejecting the second null hypothesis. The highest number of slices in images at 5  $\mu\text{m}$  may have contributed to better capacity to detect the thinner continuity of microcracks, since micro-CT high-resolution scans were recommended to provide more accurate analysis of microstructures.<sup>30</sup> On the other hand, considering that statistical significance is dependent on the sample size<sup>35</sup> and that each cross-sectional image was used for statistical qualitative tests,<sup>9,12,14</sup> the larger number of slices observed at the higher resolution (5  $\mu\text{m}$ ) may have contributed to the statistical significance observed in the analyses before and after preparation with HEDM performed at 5  $\mu\text{m}$ .
