Hydraulic performance and degradation of geotextile tube in sediment dewatering: A remediation study

ABSTRACT: Geotextile tubes are a technology used in different sectors, such as water supply and sanitation, mainly in the final stage, to dewater the sludge generated in wastewater and water treatment plants. This paper presents geotextile tubes at the beginning of the water supply system (i.e. catchment). This paper shows a large-scale remediation project that used geotextile tube dewatering technology to desand the stream where part of the water catchment of São Carlos city – (São Paulo, Brazil) is carried out. This paper aims to present the system's hydraulic performance and the geotextile degradation. The effluent quality throughout the operation was monitored. Granulometric distribution at different heights of the filter cake is presented to better understand the deposition of particles inside the geotextile tube during the dewatering process. Decreases were observed in the geotextile's tensile strength and permittivity properties after application.

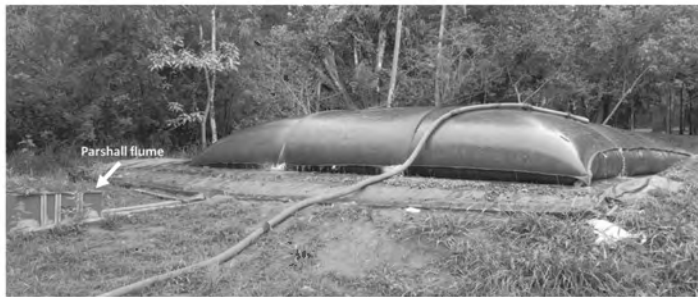
tube meets Sabesp's technical specification (NTS 301 2015), which establishes reference values for the dewatering application. The geotextile tube (Figure 2) was 10 m wide and 15 m long with a maximum height of 2.3 m (indicated by the manufacturer). The tube was installed on a dewatering platform, consisting of a High-Density Polyethylene geomembrane (1.00mm), and a draining geocomposite with a double layer of 200 g/m² nonwoven geotextile. The draining geocomposite was used to replace the layer of gravel and the layer of nonwoven geotextile of 300 g/m² suggested in the NTS 301 (2015). The stream sediments were pumped into the tube with a pump of 100 m³/h. The percolate from the tube was returned to the stream through a channel. A Parshall gutter was installed in the channel to measure the outflow (Figure 2). The sediments had a specific gravity of 2.74 g/cm³ and a grain size distribution of 88.8% sand, 4.9% silt, and 6.3% clay.

Figure 2. Geotextile tube.

The geotextile tube was manufactured from woven polypropylene geotextile, with the following characteristics: apparent opening of 0.343 mm, tensile resistance in the machine direction (MD) of 78.2 kN/m, and 106.5 kN/m in the cross direction (CD). The geotextile
