# Contribution to the study of cutting mechanism of Capão Bonito Granite, São Paulo State, Brazil

Wildor Theodoro Hennies & Antonio Stellan Junior

Mining Engineering Department, Polytechnic School, University of São Paulo, Brazil

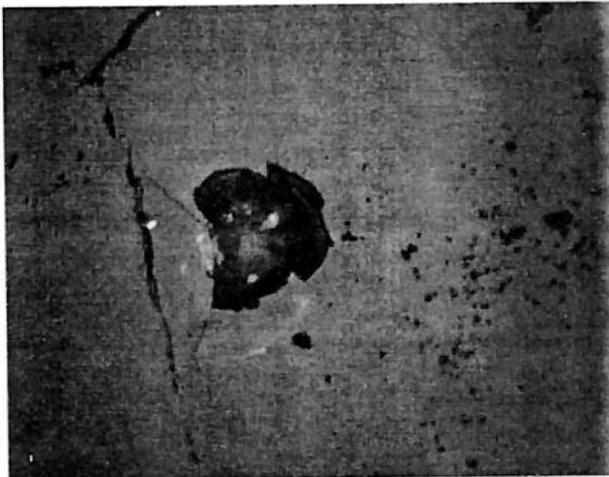
Figure 3. Indented sample paralel to rift.

At figures 2, 3 and 4 above, it is possible to notice that the indentation promote a series of cracks that may identify other features as follows:

- 1 A white indentation point area with intense fragmentation making the whole area white.
- 2 Area of the conchoidal fracture with different dip angles, promoting the whitening and iridescence of the quartz mineral.
- 3 Area of radial and vertical fractures.
- 4 Area of concentric and vertical fractures.

Careful petrographic examination of the defective slabs compared to the normal samples indicates the existence of indentation streaks parallel to direction of sawing of the slab that caused quartz fragmentation and iridescence along these streaks. This is similar to the results obtained in the microhardness tests in which there are punctual fragmentation and iridescence marks.

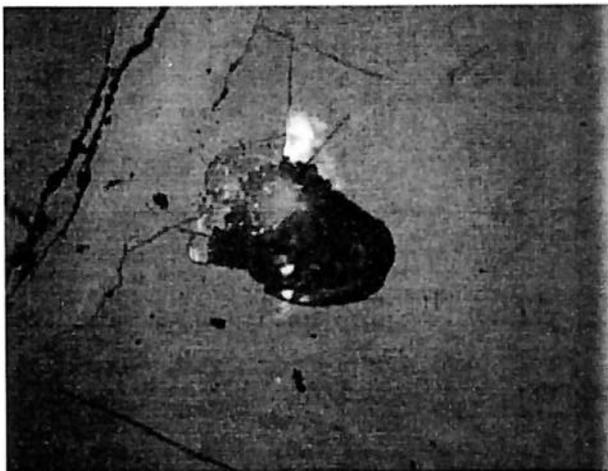
Figure 4. Indentation paralel to rift direction.
