Development of a post-occupancy assessment method system to evaluate the durability of external cladding of prefabricated timber panels

To cite this article: L A Scrideli *et al* 2024 *IOP Conf. Ser.: Earth Environ. Sci.* **1363** 012097

Table 1. Case Studies Overview

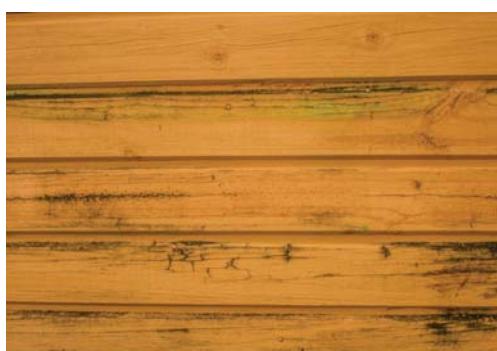
Figure 1. Example of rotted parts

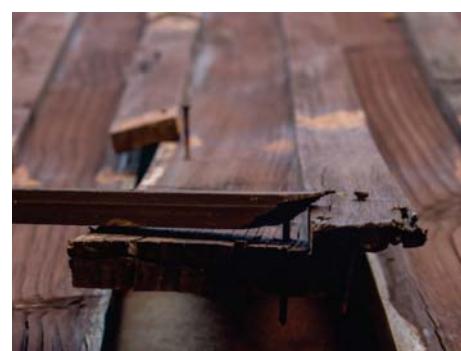
Figure 2. Example of detachments

Figure 3. Example of wood knots

Figure 4. Example of cracks

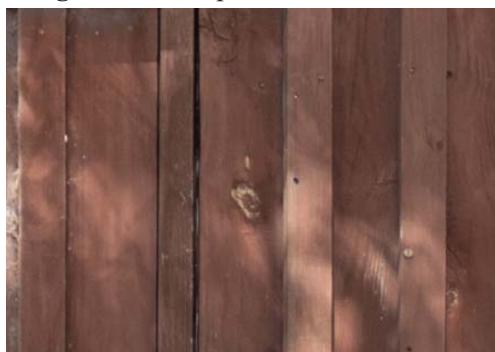
Figure 5. Example of wood planks

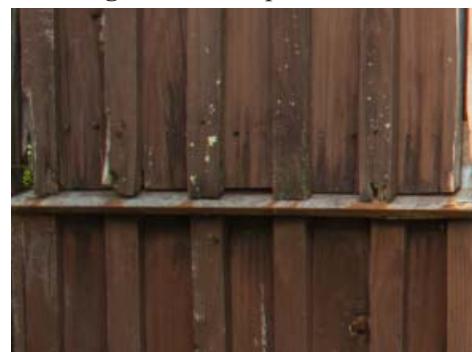
Figure 6. Example of sill failure

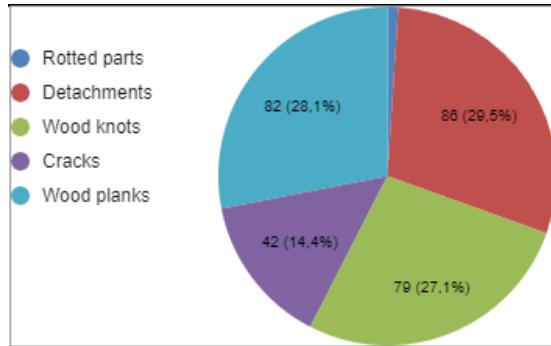
Figure 12. Graphic of the general data
(001 – Nomads)

Total parts	309
Rotted parts	3
Detachments	86
Wood knots	79
Cracks	42
Wood planks	82
Sill failure	0

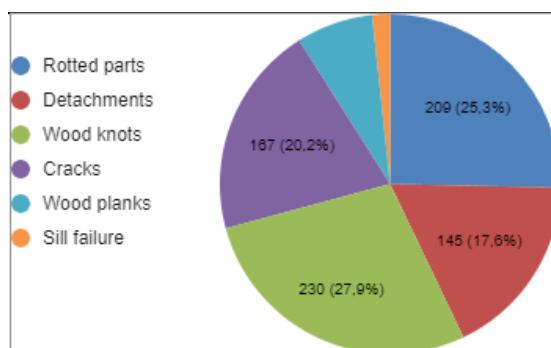
Figure 13. Graphic of the general data
(002 – HABIS)

Number of modules	18
Total parts	256
Rotted parts	209
Detachments	145
Wood knots	230
Cracks	167
Wood planks	60
Sill failure	14W

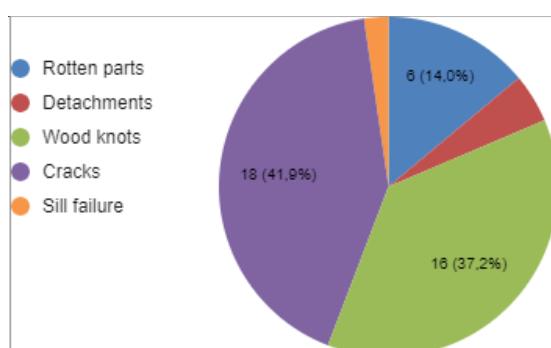
Figure 14. Graphic of the general data
(Casa do Horto)

Number of modules	10
Total parts	163
Rotted parts	6
Detachments	2
Wood knots	16
Cracks	18
Wood planks	0
Sill failure	1

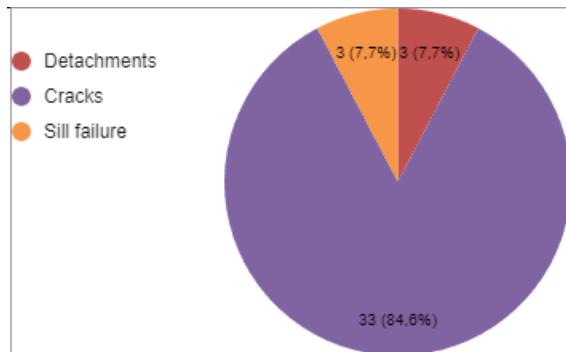
Figure 15. Graphic of the general data (Imaflora)

Number of modules	7
Total parts	143
Rotted parts	0
Detachments	3
Wood knots	0
Cracks	33
Woodplanks	0
Sill failure	3

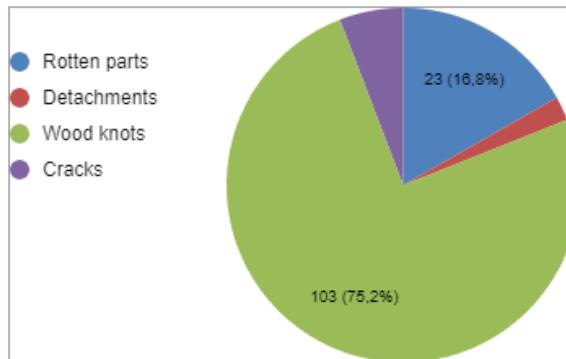
Figure 16. Graphic of the general data (Mananciais)

Number of modules	6
Total parts	412
Rotted parts	23
Detachments	3
Wood knots	103
Cracks	8
Woodplanks	0
Sill failure	0

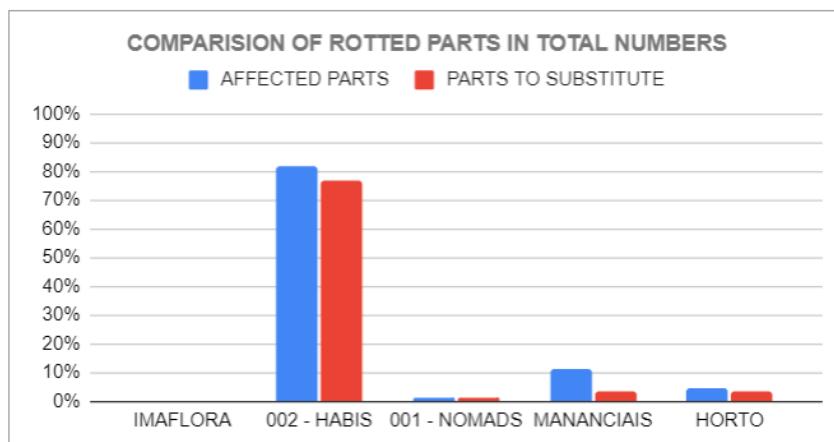
Figure 17. Graphic of the comparision of rotted parts in total numbers

Building	Total parts evaluated	Number of affected parts		Number of parts to be substituted		Affected parts to be substituted
001 – Nomads	309	3	1,0%	3	1,0%	100,0%
002 – HABIS	256	209	81,6%	196	76,6%	93,8%
Casa do Horto	163	7	4,3%	6	3,7%	85,7%
Imaflora	143	0	0,0%	0	0,0%	0,0%
Mananciais	206	23	11,2%	7	3,4%	30,4%

The method developed showed that the construction techniques used significantly affect the durability of external cladding panels. Factors such as the type of wood species used, maintenance routine and frequency, material treatment, solar exposure, presence of eaves, and correct project directions all play a crucial role. It is essential to consider these factors to ensure the longevity of the cladding panels.
