## INFRARED THERMOGRAPHY FOR IMPACT DAMAGE ANALYSES ON CURVED CFRP LAMINATES USED IN GEOSTATIONARY SATELLITES

**Keywords:** carbon fiber-reinforced thermoplastic, impact loading, infrared thermography, curved geometry

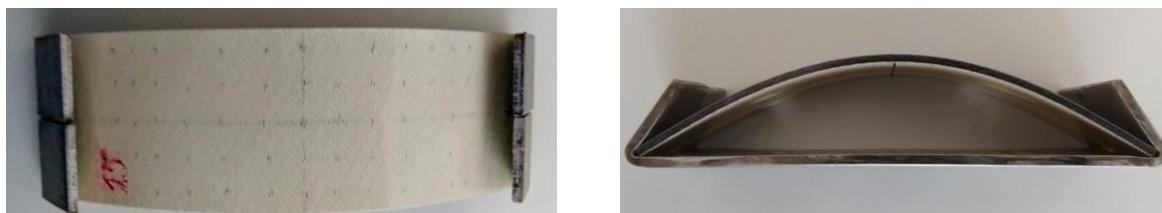
**Figure 1** – Frontal (left) and lateral (right) view of a sound specimen for NDT inspection

Specimens inspected in this work were prepared in order to mimic the conditions found in geostationary satellites. PPS-C Cetex TC1100<sup>TM</sup> laminated coupons were manufactured in [0/90]<sub>4</sub> stacking configuration and subsequently curved (~120 mm) at room temperature. After that, they were subjected to rapid and large temperature-range thermal cycles (i.e., thermal shock condition), by rapidly alternating immersion in, respectively, boiling water and liquid nitrogen with short dwell times to avoid liquid absorption to simulate the most critical thermal condition a geostationary (LEO – Low-Earth-Orbit) satellite can experience. Thermal cycles were applied 0, 150, 300 and 500 times for different specimens. Finally, the coupons were transversely impacted with a cylindrical projectile with 50 J kinetic energy to simulate micrometeoroid impact that can lead to delamination damage to laminate composites. Figure 1 shows an example of an inspected specimen, and Table 1 lists all inspected specimens.

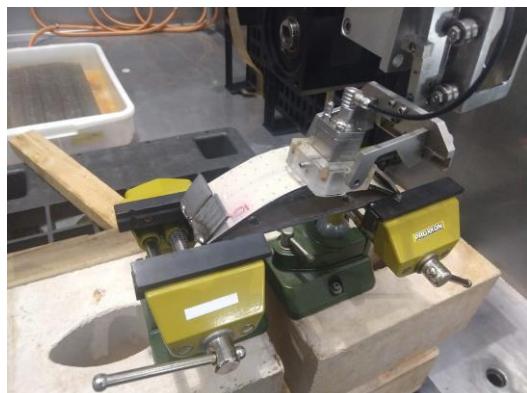
**Figure 5 - UT inspection**

Specimens were then submitted to ultrasonic inspection. A 5MHz transducer controlled by a robotic arm was used for inspections. The transducer was moved on the surface of the specimen, and an area of around 38 x 75 mm, with the impact region on the center, was inspected. Figure 5 shows one of these inspections.

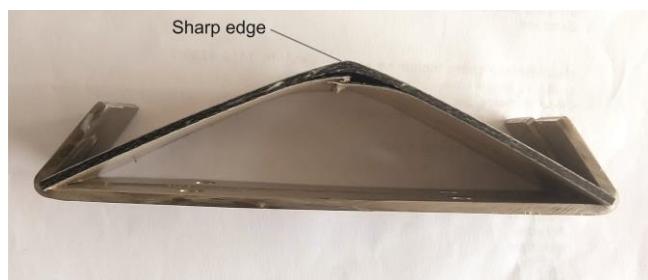
**Figure 6 - Specimen 13**

The transducer moved smoothly through the surface of all specimens, except for specimen 13. The impact in this sample caused a sharp edge on the surface of the specimen. Therefore, the transducer had contact problems when passing on the top of specimen 13. This led to a faulty image reconstruction. Figure 6 shows this problem.
