# A Short Review on the Importance of Colonnades, Entablatures and “Fault Joints” for the Excavation of Basaltic Rocks

**Abstract.** Entablatures, colonnades and “fault-joints” have been found in many excavations of dam foundations, tunnels and quarries in basaltic rocks of southern Brazil, but frequently they were not formally identified as such, and the two first, only rarely. This lack of recognition led many times to misunderstanding of their importance to slope stability and foundation problems. This short note reviews their basic definitions and stresses the influence of their properly consideration in the development of geotechnical projects.

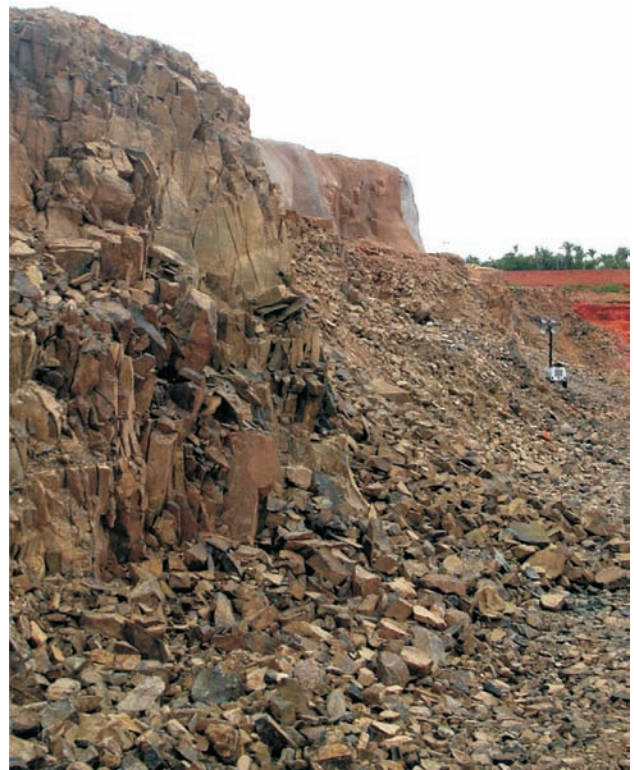
**Figure 4** - Slope cut raveling in loosened entablature basalt.

thin films of minerals (Fig. 3). They are tightly closed in fresh rock and opened in weathered rock masses, where hackles turn to be more evident and help to induce fragmentation of the columns and thus, some raveling in open cuts (Fig. 4).

tional permeability in dam foundations and to a higher potential of rock raveling at high cuts (as in Fig. 4). The raveling and the ease of excavation or even risk of over-excavation in the more superficial horizons with the use of machines has been observed, particularly once one breaks the small cohesion between the partially welded columns (Fig. 9). However in what concerns permeability or bearing strength of the mass, no special problematic behavior has been determined. Both aspects ask for careful blasting in order to achieve the desired design profile.

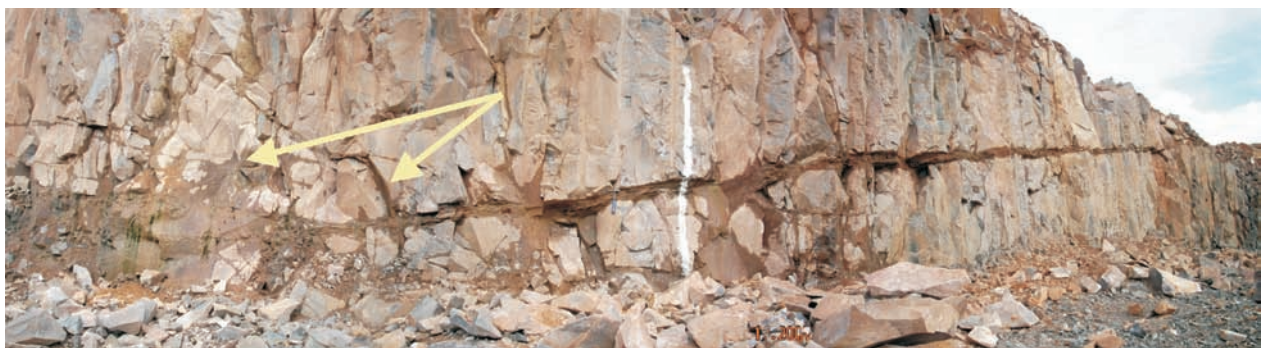
**Figure 7** - “Fault-joints” in basalts of Northern Brazil. Observe ramifications on the left end. The photo was taken during dam construction.

hibiting striations which allowed some tectonic speculations. Their origin has been related to different mechanism such as differential contractions during cooling, stress relief effects or even shallow tectonics. Being relatively permeable, they are frequently percolated and affected by differential weathering. Consequently, the laminated platy rock of the densely jointed zone may be totally or partially weathered. Shear strength properties are usually substantially lower than those of the rest of the rock mass. Mohr-Coulomb strength parameters have been determined, some with the help of “in situ” shear tests, to spread frequently around  $\sim 0.05$  MPa for the cohesion and a  $\phi$  of around  $20$  to  $35^\circ$  depending on the type of filling or the presence of evidences of pre-shearing (Marchi & Cury Jr., 1983) (Fig. 6). Figures 7 and 8 show their aspect in other dam construction sites.

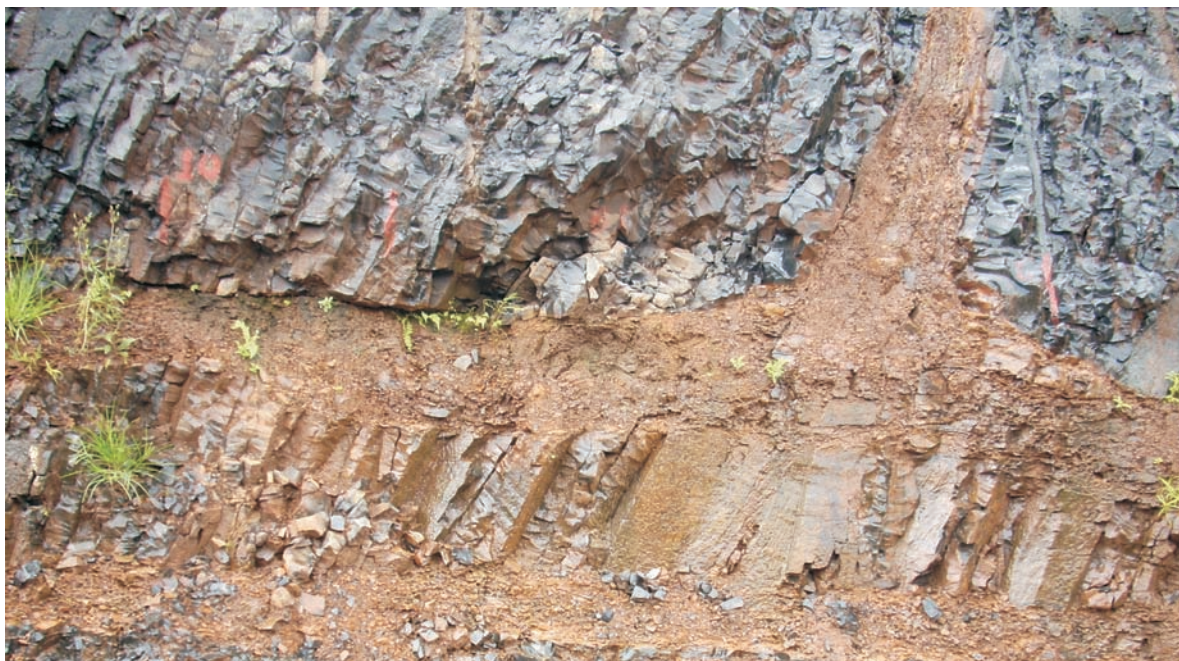
**Figure 8** - Weathered “Fault-joint” between colonnade and entablature (upper realm) at a dam construction site in Parana Basin basalt flow in the São Paulo State.

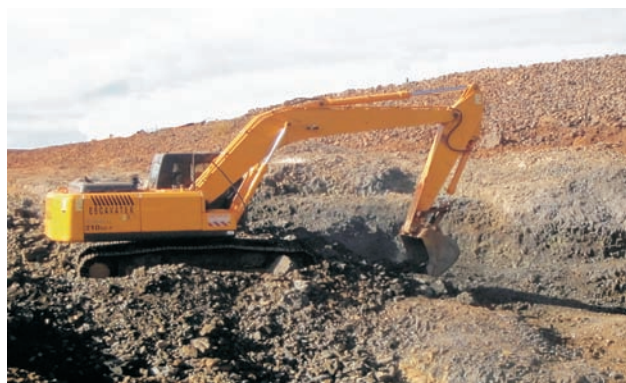
**Figure 9** - Machine excavation of blocky, partially weathered entablature. São Paulo State.
