TENSILE BEHAVIOR OF PULTRUDED COMPOSITE RODS EXPOSED TO DIFFERENT ENVIRONMENTAL CONDITIONS

L. V. Silva^{a*}, F. W. Silva^a, F. F. Luz^a, J. R. Tarpani^b, S. C. Amico^a

Keywords: fiber-reinforced polymer matrix composites, hygrothermal aging, pultruded rods, residual tensile properties.

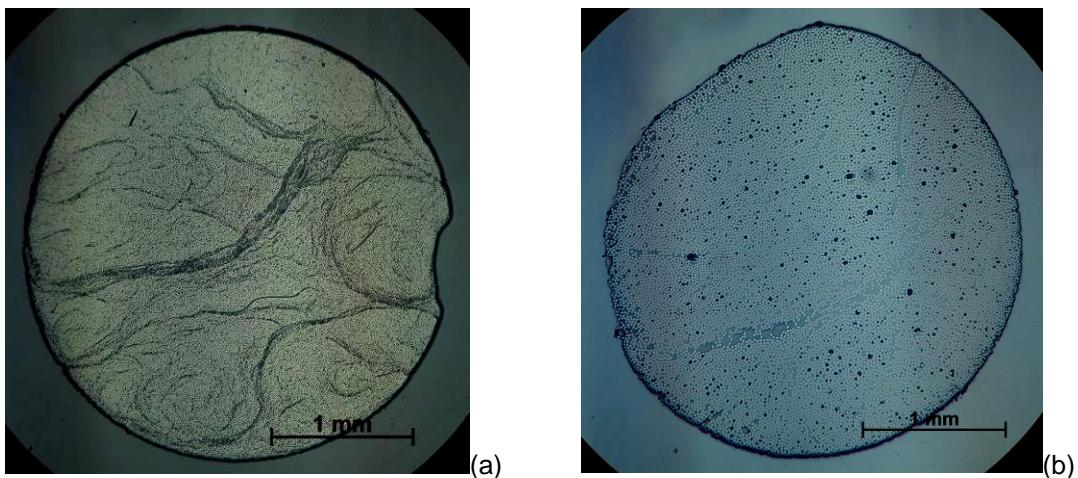
As shown in Figure 1, the rods have a typical pultruded structure with few voids and a high fraction of fiber-reinforcement, as listed in Table 3. The fibers are all aligned, homogeneously distributed in the resin and well compacted, revealing good resin infiltration during the manufacturing process, which can be better appreciated in Figure 1a referring to the glass fiber / vinyl-ester composite (VV30). These characteristics are much desired because they are directly related to improved mechanical and physical properties of processed materials. The values of diameter, density and fiber volume fraction of the rods in the as-received condition are presented in Table 2.

Figure 1. Micrographs of the cross section of the rods: (a) CV30, and (b) VV30.
