Article

Mechanical Properties, Wear Resistance, and Reliability of Two CAD-CAM Resin Matrix Ceramics

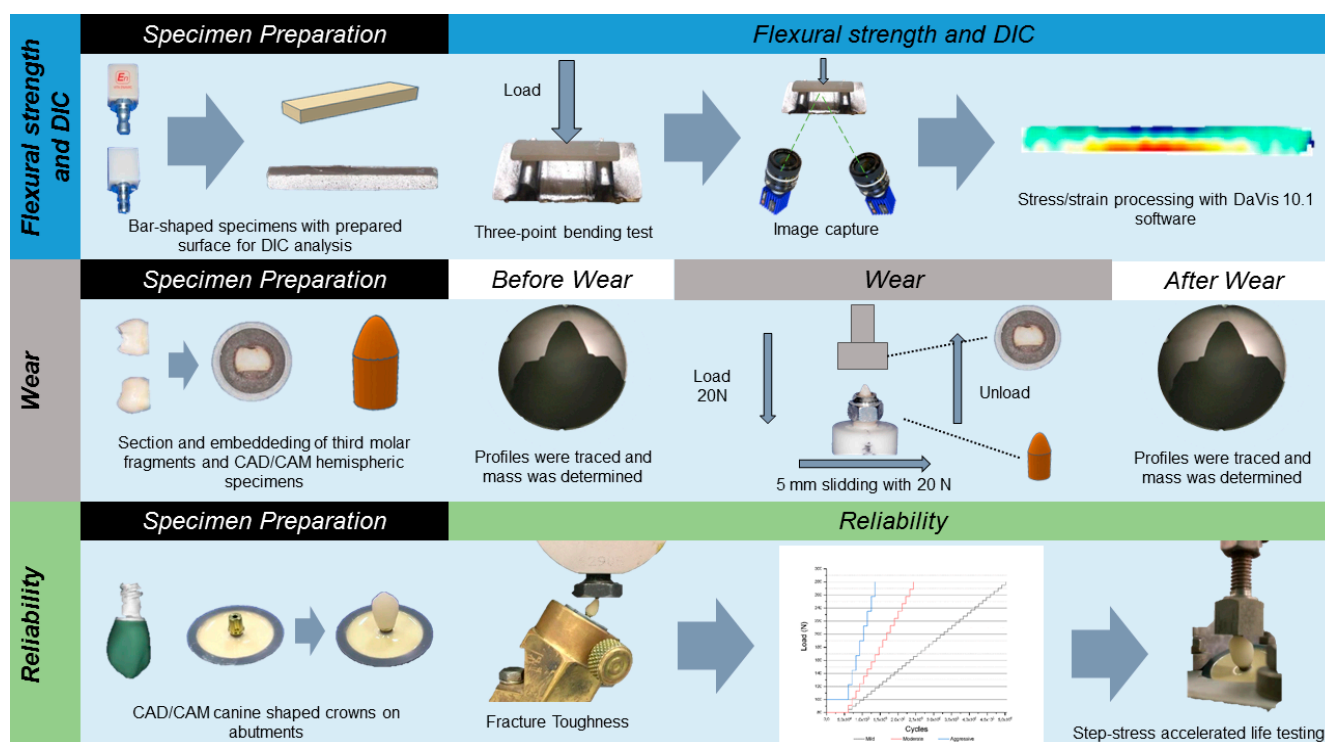
Figure 1. Experimental design representing the workflow adopted for the performed analyses.

Two resin matrix ceramics (Table 1) for CAD-CAM were evaluated following the workflow shown in Figure 1.

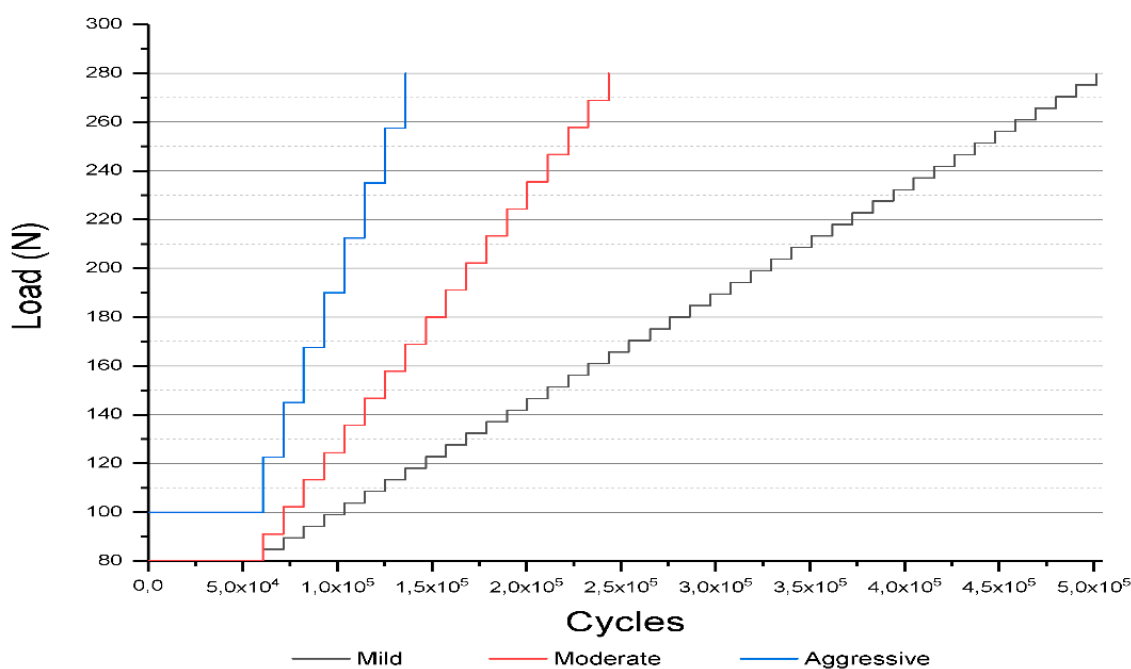
Figure 2. The step-stress profiles utilized for accelerated life testing (SSALT) on the basis of the mean value of single load to failure (SLF).

Three maxillary canine-shaped crowns ($n = 3$) of each group underwent single load-to-failure (SLF) testing at 30° inclination using 1000 KgF load cell and crosshead speed of 1 mm/min in a universal testing machine (Biopdi, Sao Carlos, Brazil) [18,19]. On the basis of mean SLF values, crowns were assigned to three step-stress profiles (Figure 2) used in step-stress accelerated life testing (SSALT) following 3:2:1 ratio and designated as mild ($n = 9$), moderate ($n = 6$), and aggressive ($n = 3$). This methodology was used to evaluate and compare the reliability of ceramic materials under accelerated lifetime fatigue test [20]. The maximum load used in the aggressive step corresponded to 60% of the average values obtained in the SLF.

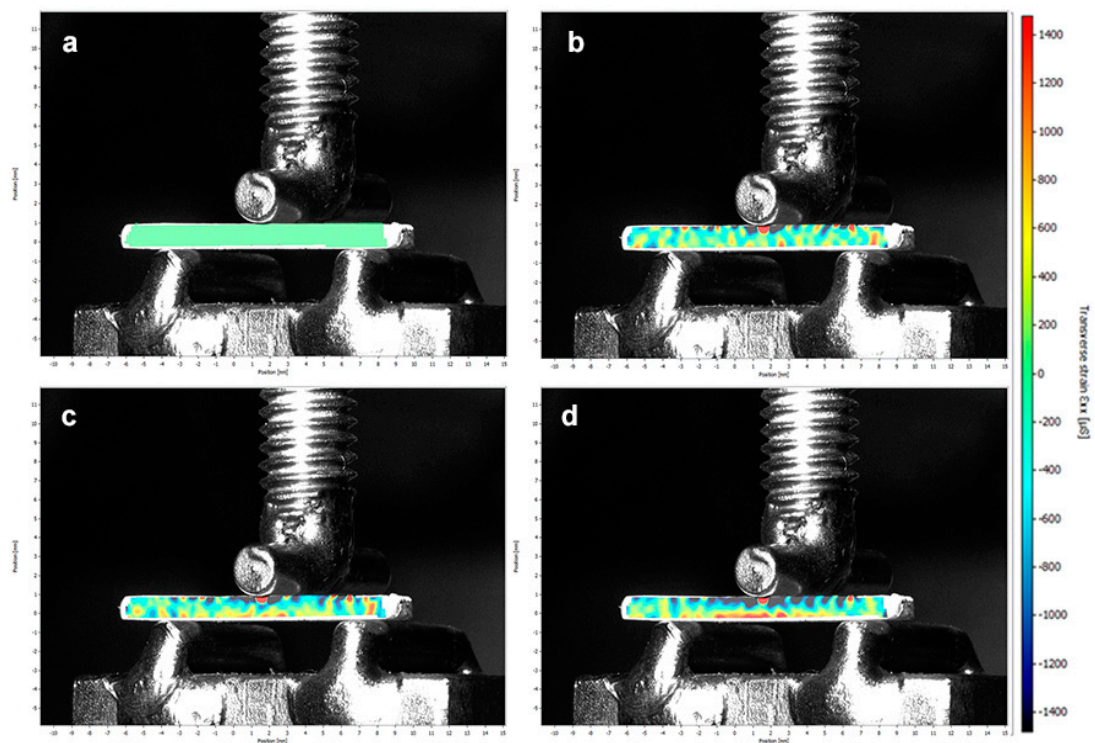
Figure 3. The sequence of photographs obtained in the DIC analysis of the material VE: (a) without strain concentration; (b) when the test starts; (c) with more load on specimen the strain concentration increases; and (d) the last photograph before failure.

The results of DIC represent qualitatively the distribution of horizontal strain on the specimen during the three-point bending test (Figures 3 and 4). Cold colors (blue to green) represent compressive strains, and warm (red to green) colors represent tensile strains. The horizontal stress values indicated by the color scale agree with the results obtained during the three-point bending strength test; the image relative to material AH shows higher microstrain (μS) values than material VE, which indicates the need for a higher load applied until the failure.

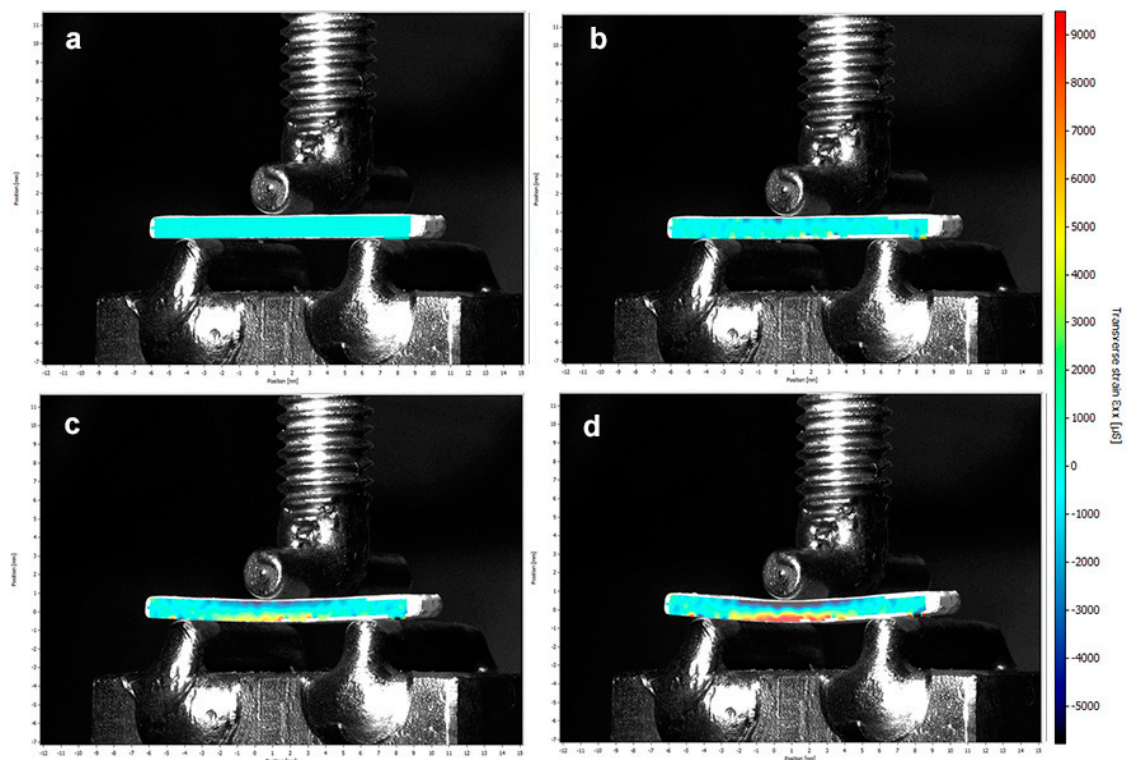
Figure 4. The sequence of photographs obtained in the DIC analysis of the material AH: (a) without strain concentration; (b) when the test starts; (c) with more load on specimen the strain concentration increases; and (d) the last photograph before failure.

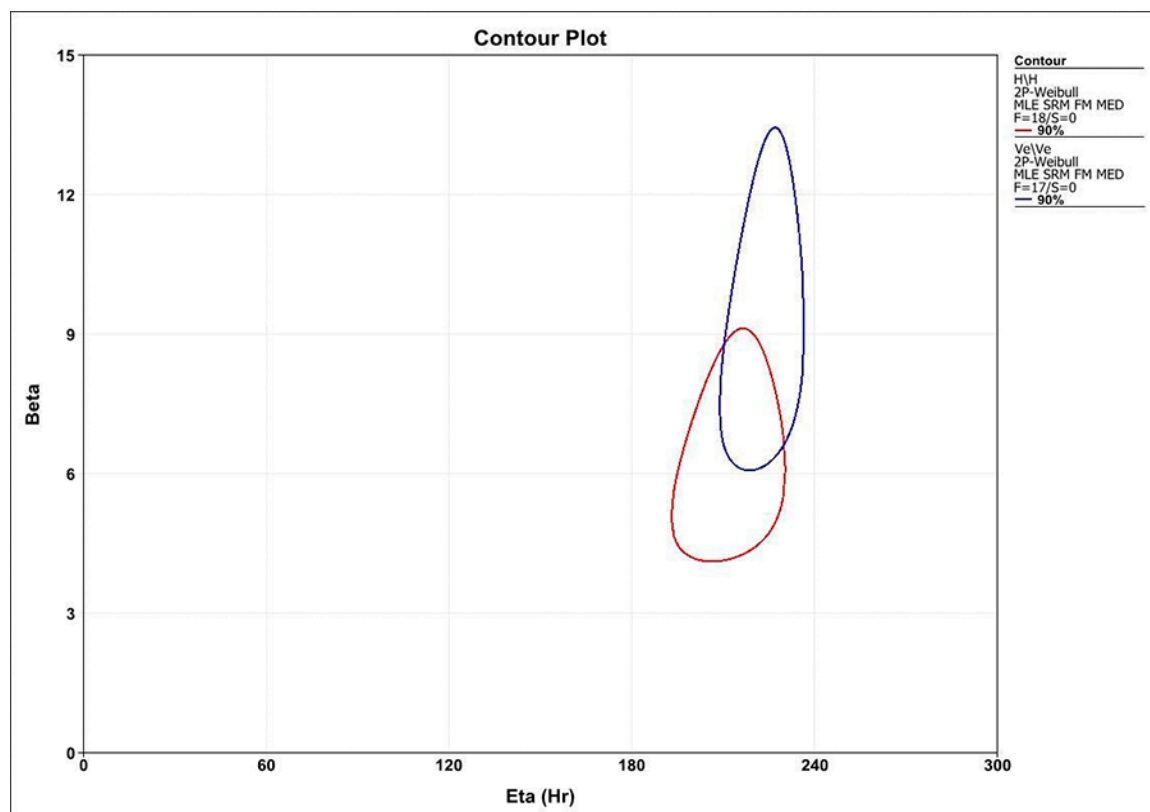
Figure 5. Contour plot: Weibull modulus vs. characteristic resistance (the red contour shows the results for the AH material and the blue contour for the VE material).

The graph and summary statistics for level probability derived from the Weibull step-stress with 150 N usage stress are presented in the Figure 5 and Table 3. The mean values of β (confidence interval limits) derived from the Weibull calculations of the probability of use (probability of failure versus number of cycles) were 0.5 for AH and 0.38 for VE. The resulting β values indicated that, regardless of the stage stress level at which the samples were fatigued, failures were associated with load (level of stress) rather than accumulation of fatigue damage. Thus, the Weibull distribution probability was determined using failure load during fatigue.

The Weibull modulus (m) was 6.41 (upper limit: 8.66; lower limit: 4.74) for AH and 9.43 (upper limit: 12.73; lower limit: 6.99) for VE. The characteristic resistance values (η) were 211.25 N (upper limit: 225.04 N; lower limit: 198.31 N) for group AH and 222.64 N (upper limit: 232.83 N; lower limit: 212.89 N) for the VE group. The contour plot (characteristic strength vs. Weibull modulus) exhibits this information graphically and detects that these datasets are from similar populations ($p > 0.05$) on the basis of the overlapping confidence limits (Figure 5). The calculated reliability was similar for the two materials at any given mission ($p > 0.05$). The behavior of the groups is closer in the 100,000 cycles mission under a load of 150 N. With the load in 200 N, for a mission of 100,000 cycles, there was a decrease of 62.16% for AH and 48.89% for VE when compared with the load of 150 N. With the increase in the number of cycles to 150,000 and loading retained at 200 N, there was a decrease of 25% for group AH and 13.04% for group VE, when compared with the mission of 100,000 cycles, with the VE material for the longest mission in 200 N being the least affected.
