IBRACON Structures and Materials Journal

ORIGINAL ARTICLE

Non-destructive tests for performance evaluation of selfhealing concrete by addition of methyl methacrylatecontaining microcapsules

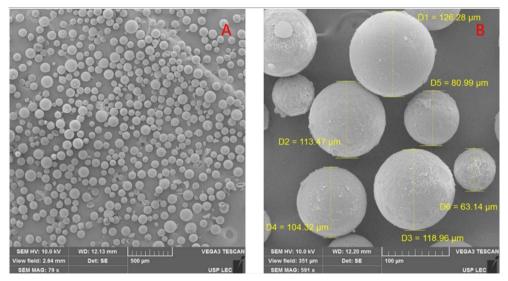
The images revealed that the obtained microcapsules have a well-defined rounded shape with an average size distribution between $60\mu m$ and $120\mu m$. In addition, it was observed no agglomeration tendency for the microcapsules, what makes their dispersion in concrete matrix easier.

Figure 7. Images of microcapsules obtained by SEM: (A) Overview and (B) Approximate view with detail of measurements.

Comparing the particles sizes indicated by SEM and laser diffraction analysis, it can be seen that a major part of microcapsules presents diameters from 60µm to 167µm. The dimensions of microcapsules obtained in this work are similar to those observed in other studies developed on the same topic [33], [34].

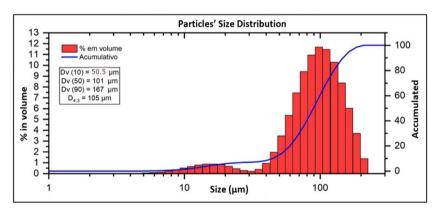
To assess their size distribution, the microcapsules were evaluated by the laser diffraction method. The Figure 8 presents a histogram of volumetric distribution and a curve of accumulated values. In the histogram, two populations of microparticles can be seen (bimodal distribution), one of low and another of high volumetric intensity. The population with low volumetric intensity presents microcapsules with sizes between $6\mu m$ and $30\mu m$ while the one of high intensity is composed by microcapsules between $40\mu m$ and $110\mu m$.

Figure 8. Volumetric distribution histogram and cumulative value curve of synthesized microcapsules.

The average volumetric diameter D (4,3) found using this technique was equal to $105\mu m$. The volumetric diameters Dv (10), Dv (50), and Dv (90) showed that 10% of the sample's volume is composed of microcapsules with diameters up to $50.5\mu m$, 50% of the sample's volume has diameters up to $101\mu m$ and 90% of the sample's volume has diameters up to $167\mu m$, respectively. It is important to clarify that large microcapsules are positive in this case, as it means a higher availability of healing agent to fill up fissures.

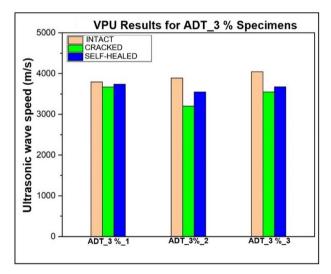
The results obtained for the specimens with 3% of addition are shown in Figure 11 and Table 12. The highest values of ultrasonic wave speed were obtained for the intact condition, followed by the self-repaired and fissured. The higher speeds obtained for the self-repaired condition in comparison to the fissured state showed that a self-repairing activity took place. However, the fissures were not completely sealed. This affirmation was made based on the difference observed between the values of the intact and self-repaired conditions. Once they were not equal, the wave speed recovery was not total.

Figure 11. UPV results obtained for specimens with 3 % addition.

The average RF obtained for the system ADT_3% was 44%. It reinforced the conclusion that the samples of this system had their fissures partially sealed. On the other hand, two of the three specimens of the system ADT_6% presented low recovery factor values. This poor performance can be related to the potentially high quantity of microcapsules broken during the mixing process.
