Article

Quartzite Mining Waste: Diagnosis of ASR Alkali-Silica Reaction in Mortars and Portland Cement Concrete

Abstract: The main objective was to determine the deleterious potential of quartzite mining tailings subjected to different ASR alkali–silica reaction tests. The studies included petrographic analysis, chemical analysis of cements, expansion tests in mortar bars and concrete prisms, and microstructural analysis. Petrographic analysis of quartzites indicated high percentages of deformed quartz (95%), and were classified as potentially reactive. Two types of HES high early strength cement with alkaline equivalents of 0.749% and 0.61%, respectively, were selected. Of the 8 samples analyzed by the accelerated method in mortars, only 2 quartzite samples and 1 diabasium sample indicated potentially reactive behavior. The accelerated and long-term methods in concrete prisms proved to be effective and were consistent with the deleterious potential of the samples. All analyzed samples were diagnosed with the ASR gel. In the microstructural analysis, in addition to the ASR products, other expansive products of late ettringite were detected. Reaction mitigation methods are propose

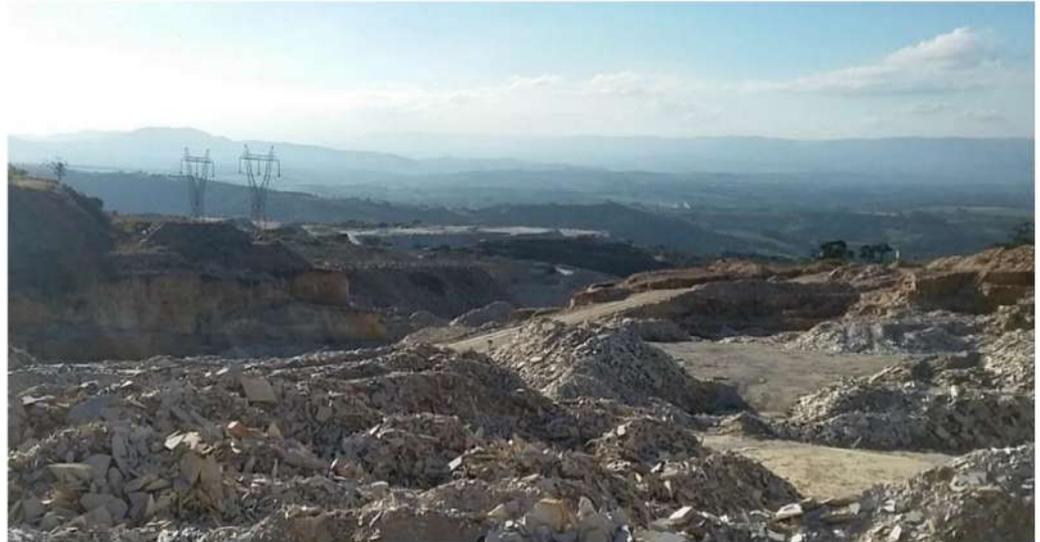
Figure 1. Example of large volumes of quartzite mining tailings.

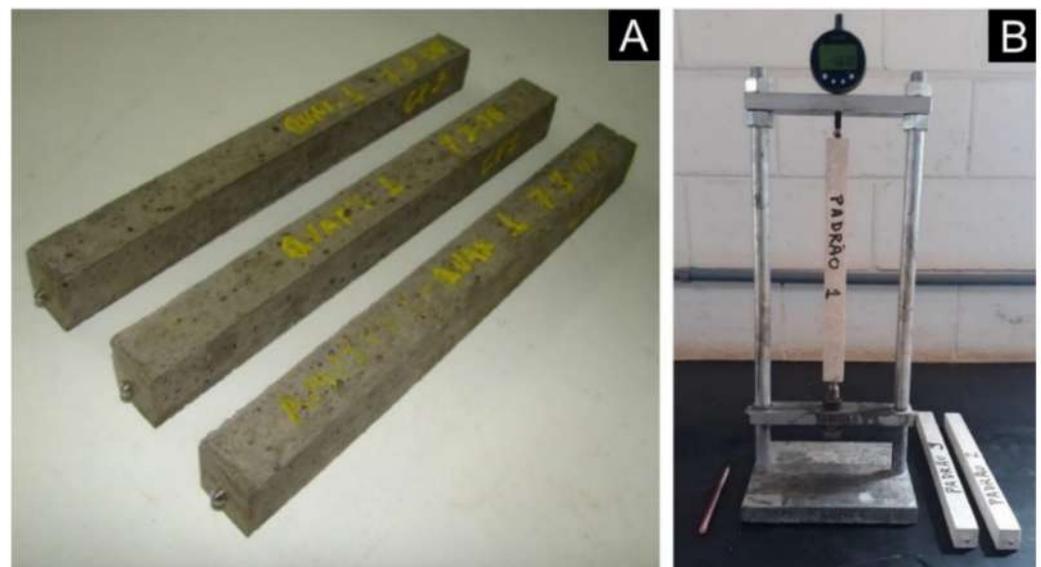
Figure 2. (A) Mortar bars; (B) Expansion measurement device.

The accelerated test method, recommended by NBR 15577-4 [25] and ASTM C1260 [21], determines through variation in length (expansion) of mortar bars (Figure 2) the susceptibility of an aggregate to participate in the alkali–silica expansive reaction in the presence of hydroxyl ions combined with cement alkalis. Three mortar bars were produced in the dimensions of $25 \times 25 \times 285 \text{ mm}^3$ with a fixed mix ratio at 1:2.25:0.47 for each of the eight samples of aggregates and subjected to alkali attack in a NaOH solution at a temperature of 80 °C.

After casting, bars remained at rest in a humid chamber. After the curing period, bars were removed from the molds, identified and the initial reading was made. Afterwards, bars were submerged in water and kept in an oven at 80 °C for 24 h. Then a new reading was taken and the bars were transferred and submerged in the standard solution with 1 N NaOH, and kept in an oven at 80 °C, accelerating the reactions and allowing the identification of results in a short period of time. Expansion readings were taken periodically, at 8, 16, 22 and 30 days, counted from the casting, and the results expressed in percentage of expansion, corresponding to the means of the three bars. For expansions of up to 0.19%, at 30 days, the aggregate was classified as potentially innocuous, and for expansions greater than 0.19%, as potentially reactive.

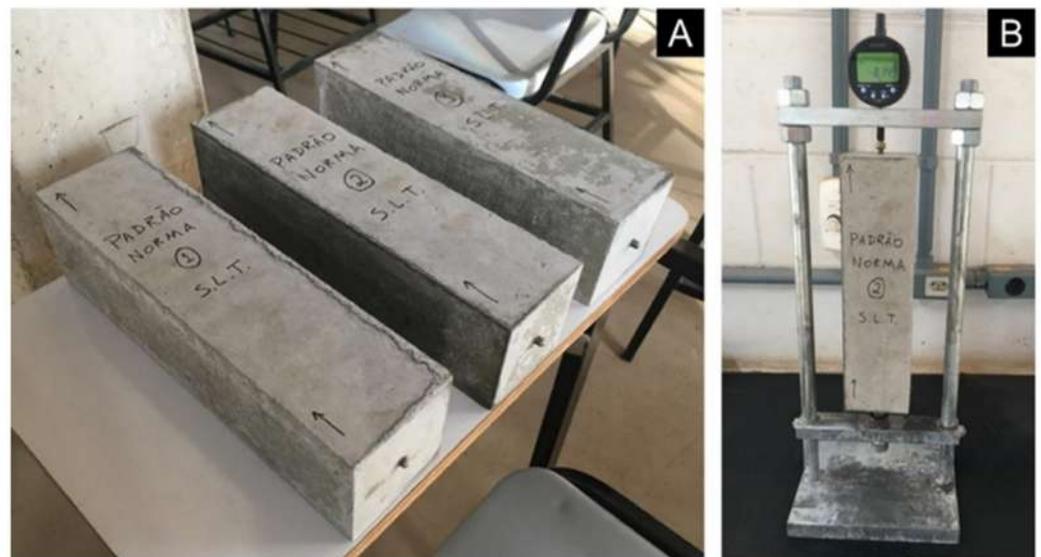
**Figure 3.** (A) Concrete prisms; (B) Expansion measurement device.

To determine expansion by the long-term method, concrete prisms were kept in a temperature-controlled environment (38 ± 2 °C). The expansion readings were taken at 7, 28, and 56 days, followed by monthly readings from 3 to 12 months. Equivalent alkali ($\text{Na}_2\text{O}_{\text{eq}}$) of the cements used to calculate and adjust the contents to 1.25% were made by adding NaOH to the concrete mixing water, using a conversion factor. STL3, ALP1 and ALP3 samples proved to be quite friable during concrete mixing and consolidation. The particles fragmented up, thus changing the particle size of the materials, and consequently the concrete consistency due to the increased specific surface of the aggregates. As an alternative to facilitate prism consolidation, without changing the w/c ratio, a superfluidizing additive was added to the mixtures. The ALP1 sample, even with the addition of the additive, was discarded for presenting a high porosity index and not meeting the consolidation conditions.

in an airtight container and subsequently taken to an oven (60 ± 2 °C). Length variation readings were taken at ages 5, 10, 15, 20, 25 and 30 weeks.

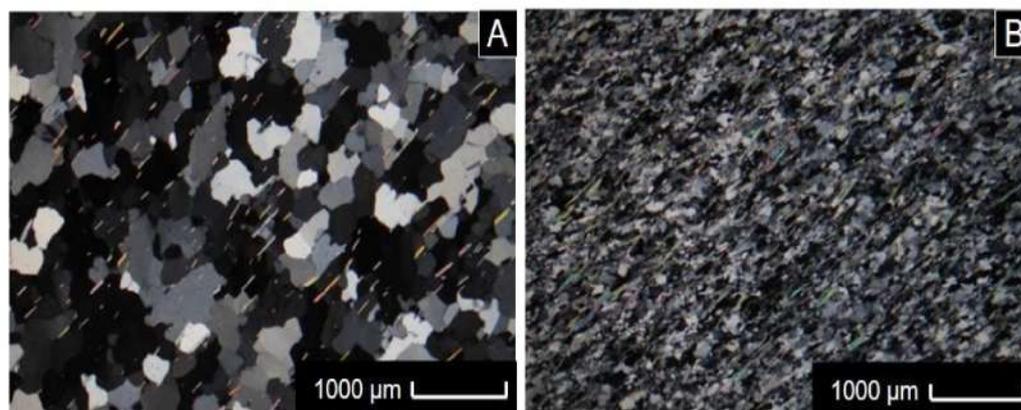
Figure 4. Photomicrographs (crossed nicols). (A) STL quartzite showing the granoblastic arrangement of quartz crystals and foliation marked by the alignment of muscovites; (B) ALP quartzite with the same textural arrangement but with considerably smaller grain size.

Quartzite samples were subjected to petrographic analysis using a transmitted light petrographic microscope. Results in Table 5 indicated small mineralogical variations of muscovite between samples of STL quartzite tailings. Microscopically, they were classified as foliated quartzites with fine muscovite, with a strongly anisotropic structure with well-oriented muscovite and grano-lepidoblastic texture, consisting of approximately 94.5% quartz and the remainder (5.5%), of muscovite, opaque minerals and tourmaline (Figure 4). Comparatively, APL samples were considerably thinner than the STL. The average particle size of STL was predominantly between 0.1 and 0.4 mm in width and about 0.2 and 0.6 mm in mineral stretching, while the average particle size of ALP was predominantly between 0.01 and 0.04 mm in width and about 0.06 and 0.1 mm in mineral stretching. Regarding the cohesion of the rocks, in general the STL muscovite quartzites were considerably more cohesive (less friable) than the ALP. This is due to the better recrystallization of the STL muscovite quartzites, considering that they are rocks with a metamorphic degree considerably higher than ALP rocks. Another factor to take into account regarding cohesion is the weathering intensity of each set of samples. In this case, the STL1 sample demonstrated the greatest weathering effects in its set, which would make it more friable than the others.

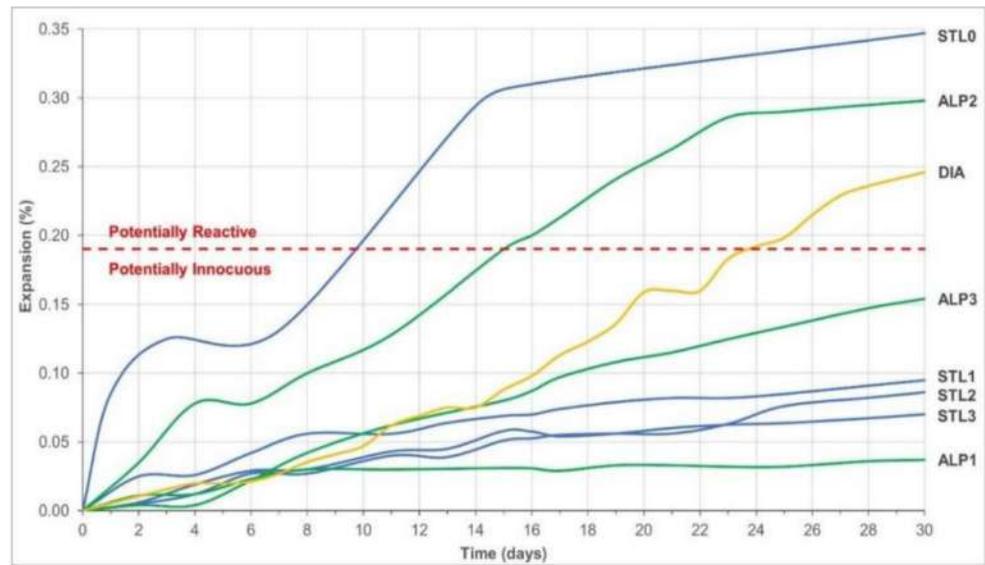
Figure 5. Summary of expansion test results by the accelerated mortar bar method.

Figure 5 illustrates a comparative overview of the average expansion of mortar bars up to the age of 30 days, tested by the accelerated method, and only the STL0 and ALP2 quartzite samples and DIA diabase showed a potentially reactive behavior, with expansions above the limit of 0.19% established by NBR 15577-1 [35], highlighting the quartzite samples that presented significant expansions in the first days of testing. Thus, to verify the occurrence of the ASR expansive gel, samples showing potentially reactive behavior were selected for microstructural analysis using SEM. Reis et al. [10] also used the accelerated method to analyze the expansion of mortars produced with ALP quartzites. The average expansion obtained was approximately 0.25% at 28 days, therefore close to the result of the ALP2 sample obtained in the present study. Barros et al. [11] studied the potential alkali–aggregate reactivity of quartzite tailings from northeastern Brazil, and reported minor expansions; however, performed only the test in mortar bars and did not investigate the microstructure of the composite. Sachlová et al. [18] analyzed quartzites from Prague–Czech, and verified expansive behavior when performed accelerated tests in mortar bars and proved ASR using SEM.

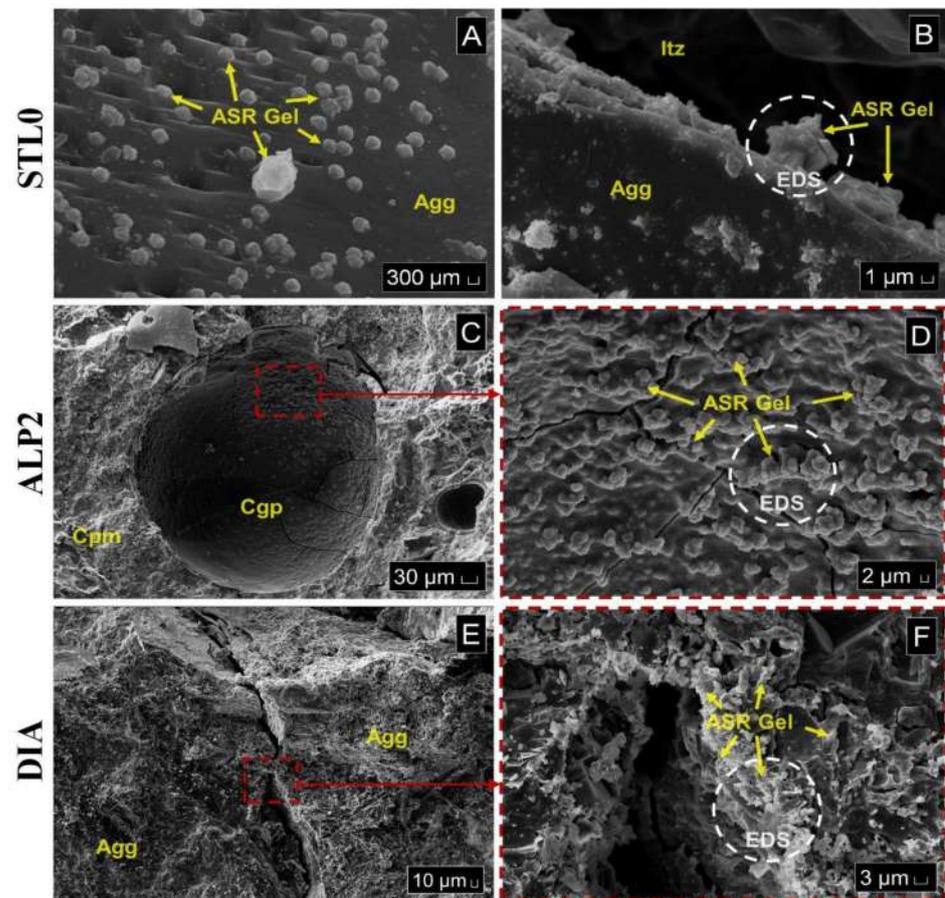
Figure 6. Mortar bar microstructure by SEM analysis. STL0: (A) Gels developed and adhered to the edge of the Agg aggregate. (B) Gels being formed on the aggregate surface close to the Itz interface transition zone; ALP2: (C) Cgp Cracked solid gel products adhered to the pore surface around Cpm cement paste matrix. (D) Detail showing the appearance of the cracked and botryoidal gel; DIA: (E) Fracture interface where the investigations were carried out. (F) Gel deposits on the aggregate surface caused by ASR.

During the microscopic investigations and the EDS analysis performed on mortar bars, it was possible to observe in the STL0 sample, characteristic products of crystallized gels adhered to the edge of the aggregate and the typical generalized formation of ASR silica gels on the aggregate surface (Figure 6A,B). In the ALP2 sample, a pore with the appearance of a solid cracked gel was identified (Figure 6C) and, after image magnification, the cracked fissures and the formation of botryoidal gel, typical of ASR, were verified (Figure 6D). The EDS spectrum analysis showed that the crystalline products generated on the aggregate surface are ASR silica gels (Figure 7A,B). The DIA diabase microstructure images were collected inside the fissure region in the sample, where the widespread presence of crystallized products was found (Figure 6E,F). These crystals were subjected to EDS analysis and the hypothesis of the formation of the ASR silico–calco–alkaline gels was confirmed (Figure 7C).

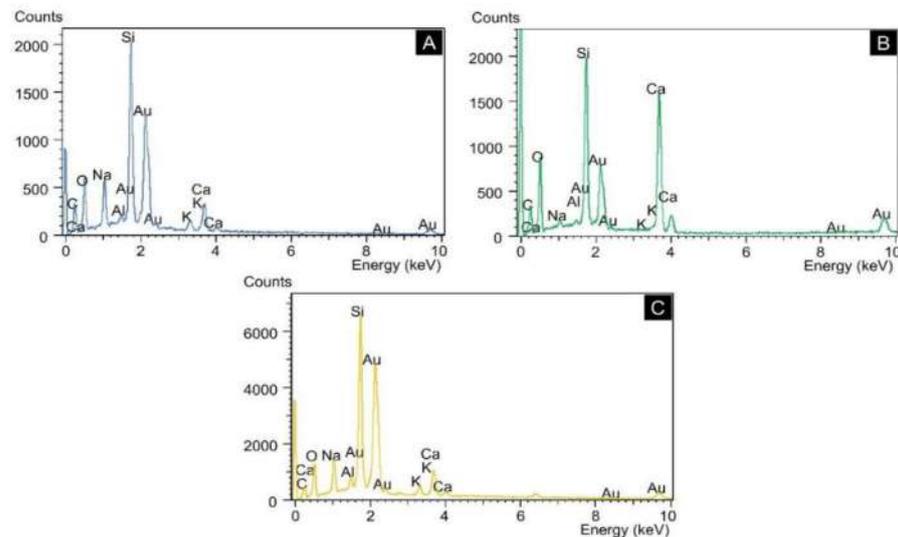
Figure 7. EDS analysis on ASR products. (A) STL0; (B) ALP2; (C) DIA.

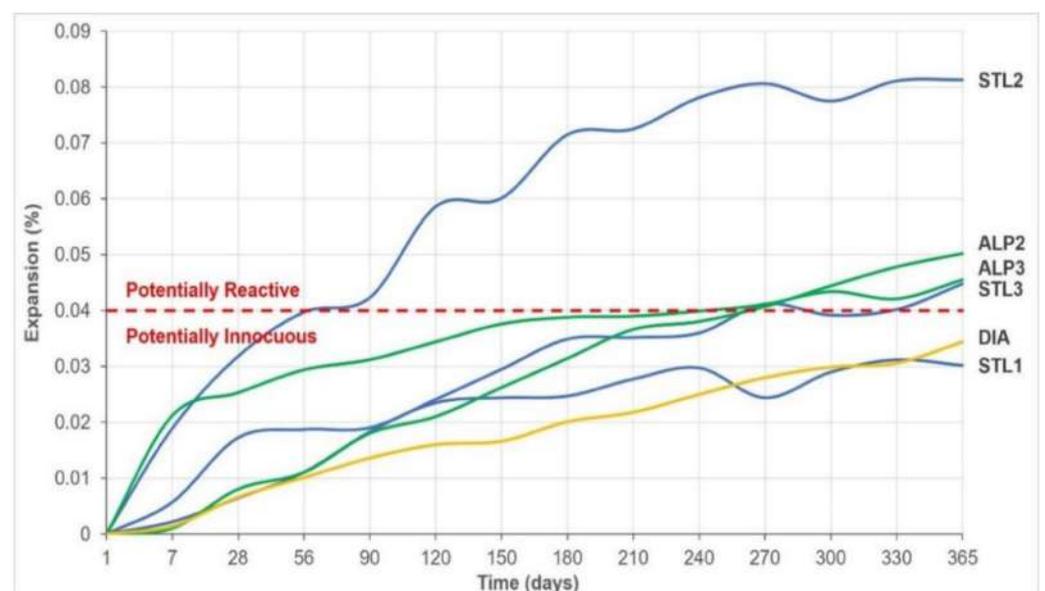
Figure 8. Synthesis of the results of the long-term expansion test on concrete prisms.

Figure 8 presents the summary of the average expansion results by the long-term method in concrete prisms, up to the age of 365 days. The STL2 sample showed a potentially reactive behavior, with significant expansion at the very beginning of the test, above the limit of 0.04% [35]. The sample did not present spalls, and no signs of fissures were observed on the prism surface, for this reason it was not selected for analysis by SEM. On the other hand, this same sample tested by the accelerated method in mortar bars showed little significant expansion, and was classified as potentially innocuous. It is important to highlight that, according to NBR 15577-1 [35], the results obtained by the long-term method prevail over those obtained by the accelerated method, as it is a more reliable procedure. The results of samples STL3, ALP2 and ALP3 up to the age of 365 days slightly exceeded the limit established by the standard, and were classified as potentially reactive. Sanches et al. [31] carried out long-term studies in concrete prisms using quartzites from the Brazilian Midwest region and reported expansions close to 0.04% at 365 days, therefore similar to the results obtained in the present study.

The average expansion of concrete prisms produced with diabase aggregate showed a potentially innocuous behavior, contrary to the test carried out by the accelerated method on mortar bars, which showed a potentially reactive behavior.

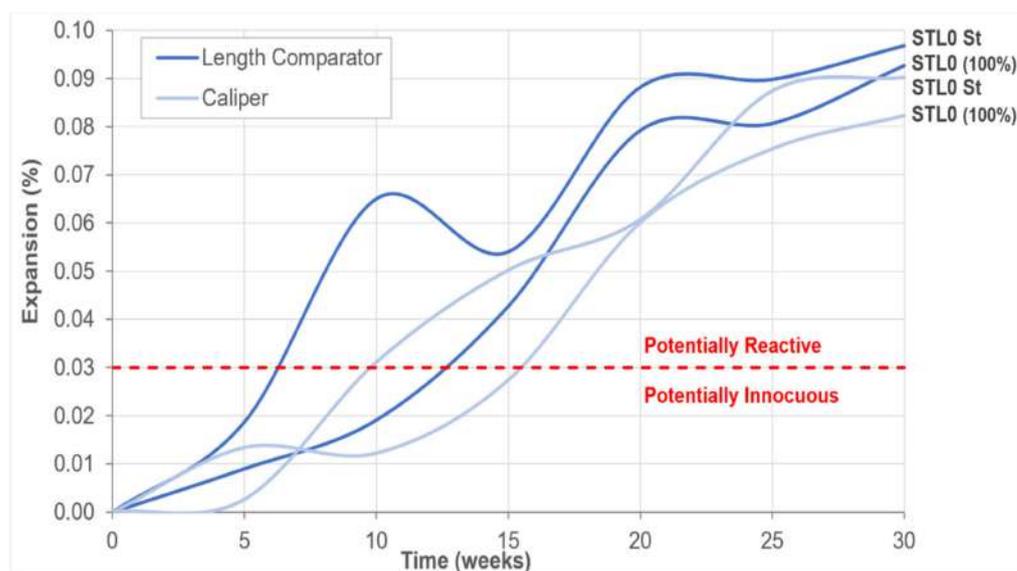
Figure 9. Summary of average expansion results by the accelerated method in concrete prisms.

Figure 9 shows the average expansion of two samples, six concrete prisms produced with 100% fine and coarse quartzite aggregate (STL0 100%) and three concrete prisms produced according to the normative standard (STL0 St). Expansion measures of concrete prisms were taken with a length comparator coupled to the measuring apparatus and comparative readings were also taken with the aid of a digital caliper. Although NBR 15577-7 [27] recommends taking the readings until the age of 20 weeks, it was decided to extend the readings until the age of 30 weeks. All analyzed concrete prisms showed a potentially reactive behavior, with expansions greater than 0.03%. The STL0 sample (100%) did not show any spans, and few signs of fissures were observed on the prism surface. The sample expansion results showed similarity with the use of the two types of measurements used. In the STL0 St sample, it was possible to observe narrow spans and generalized cracks on the prism surfaces (Figure 10). The expansion results of this sample, using the two types of measurements, showed divergences up to the age of 20 weeks, but at the ages of 25 and 30 weeks, the results started to look similar, with a progressive growth. For these reasons, samples were subjected to SEM analysis. Studies carried out by Fournier et al. [38], Wallau et al. [30] and Sanches et al. [31], in concrete samples subjected to accelerated testing using different lithological types of aggregates (including quartzites), showed that this method can be considered reliable for the interpretation of alkali–aggregate reactivity, as the results obtained were consistent with the degree of deleterious potential of the analyzed samples.

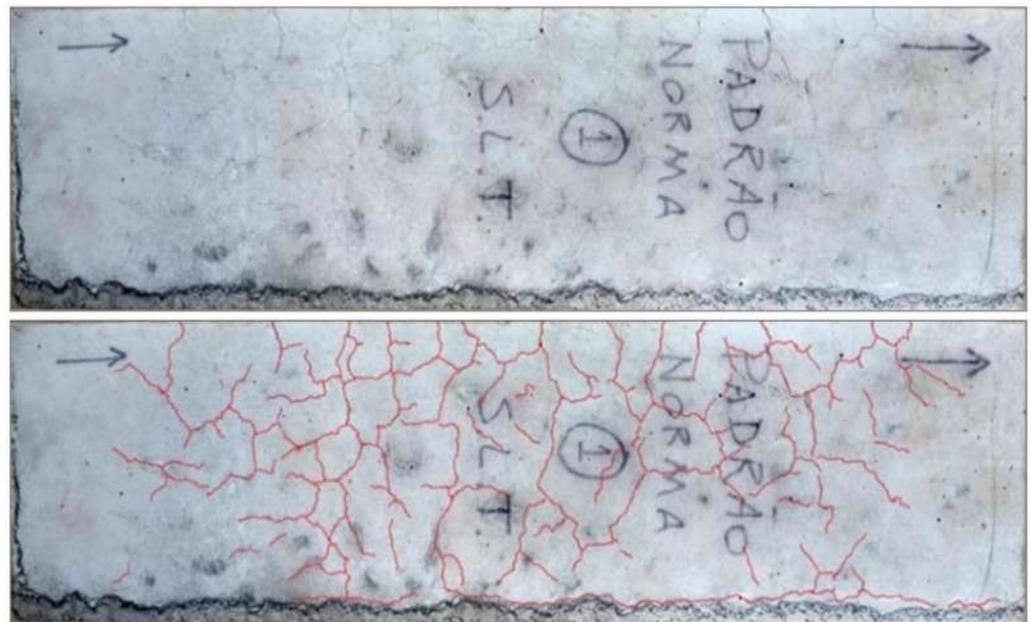
Figure 10. Typical mapped fissures (TOP— real images; BOTTOM— highlighted in red) on a face of the STL0 St prism.

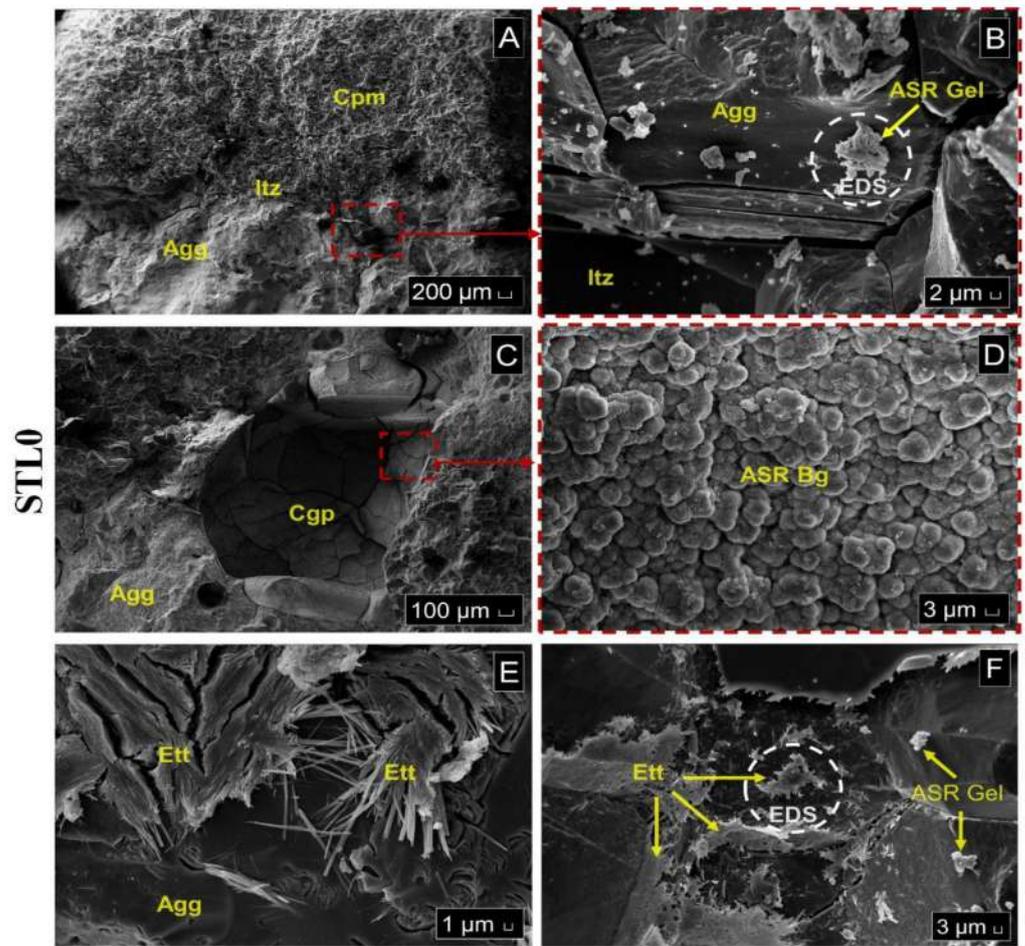
Figure 11. SEM analysis of the microstructure of mortar bars. STL0 St sample: (A) Investigated Itz interface transition zone; (B) Gel deposits on the Agg aggregate surface caused by ASR; (C) Cgp solid cracked gel products adhered to the pore surface; (D) Aspect of the Bg botryoidal gel adhered to the pore surface; (E) Ett ettringite formation on the aggregate surface. STL0 (100%) sample: (F) Typical products of ASR and ettringite formation on the aggregate surface.

Photomicrographs in Figure 11A–E are from the STL0 St sample. During the investigation, the presence of crystallized products of alkaline silico–calcium composition formed on the aggregate were observed (Figure 11A,B). In another analysis, the presence of a solid cracked gel, typical of ASR, was found inside a pore (Figure 11C) and in the same magnified image, crystallized products had a botryoidal appearance (Figure 11D). The EDS spectrum performed inside the pore evidenced that these are crystallized silicon gels from the ASR (Figure 12A). Formations suggestive of DEF delayed ettringite formation adhered to aggregate surfaces were also seen in some points in the ITZ (Figure 11E). In the investigation carried out in the STL0 (100%) sample, it was possible to verify in some points in the ITZ, the presence of crystallized silicon gels and calcium sulfoaluminate products, typical of DEF (Figures 11F and 12B).

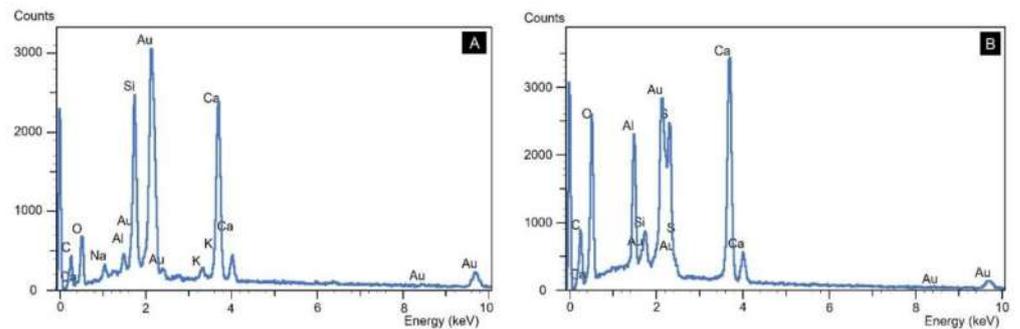
Figure 12. EDX spectroscopy analysis. (A) STL0 St; (B) STL0 (100%).
