## PERFORMANCE OF AN ENVIRONMENTAL PROTECTION LINER AFTER LABORATORY UV EXPOSURE

High-density polyethylene (HDPE) geomembranes are commonly used as an environmental protection liner due to their good chemical and mechanical resistances and low cost. Ultraviolet (UV) radiation is an essential issue in durability studies for pond applications. This study evaluated a 1.5-mm thick HDPE geomembrane exposed to ultraviolet fluorescent radiation for 8760 h in a laboratory and thermoanalytical and physical analyses were conducted towards the understanding of its performance after exposure. According to the results, although the geomembrane maintained the ductile behavior, it showed a 52.48% final decrease in stress crack resistance (SCR) compared to virgin SCR. Moreover, a considerable antioxidant depletion occurred after 8760 h exposure shown by the Std. OIT (standard oxidative-induction time) results, demonstrating a Std. OIT value decrease of 89.19% compared to the virgin Std. OIT. Such a behavior contributed to the susceptibility of thermal effects in the DSC (differential scanning calorimetry) curves and the losses observed in the SCR values, attesting the geomembrane's oxidative degr

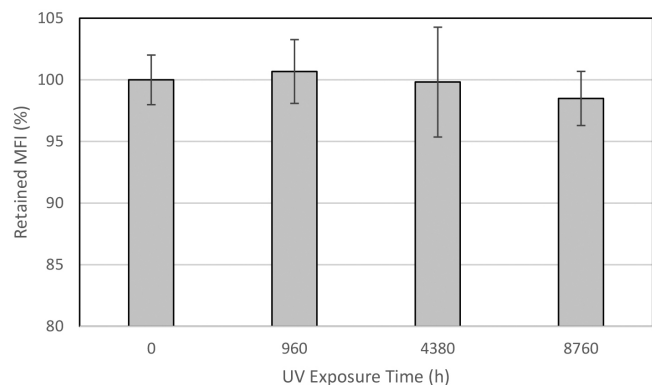
**Figure 1.** Retained MFI test results compared with virgin sample test result after UV fluorescent exposure

Table 2 shows the MFI test results for both virgin and UV fluorescent exposure samples after 960, 4380, and 8760 h and Figure 1 displays the behavior of the samples after exposure, exhibited in retained MFI results.

According to Gulec *et al.*,<sup>38</sup> the MFI test is commonly used as a molecular weight index for chemical compatibility studies; it is also a simple method for assessments of a molecular weight of the polymer. Minor variations in MFI test results were observed among the exposure samples. After 960 h of exposure, the result increased 0.68%; however, after 4380 and 8760 h of exposure, they decreased 0.18 and 1.51%. The MFI result after 8760 h demonstrates an influence of UV exposure on the polymer.

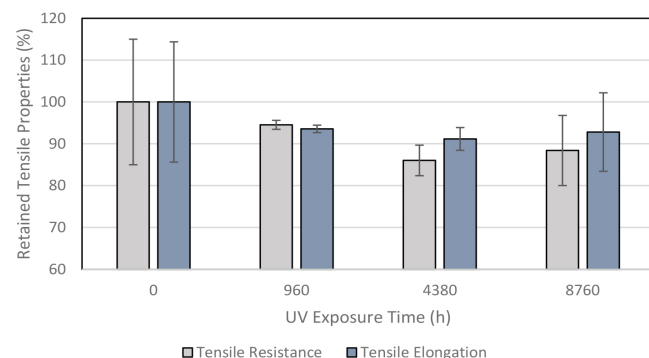
**Figure 2.** Retained tensile test results (resistance and elongation at break) compared with virgin sample test result after UV fluorescent exposure

exposure samples after 960, 4380, and 8760 h and Figure 2 displays the behavior of the samples after exposure, exhibited in retained tensile properties results.

Firstly, the virgin sample showed a high standard deviation due to a 39.25 kN m<sup>-1</sup> tensile resistance at break and a 596.50% tensile elongation at break of the specimen.

The tensile resistance at break results decreased 5.48, 13.97, and 11.60%, respectively, for 960, 4380, and 8760 h UV exposure, compared to the virgin sample. On the other hand, the tensile elongation at break decreased 6.44, 8.85, and 7.20%, respectively, for 960, 4380, and 8760 h UV exposure compared to the virgin sample. The slight increase in the tensile properties' values between 4380 and 8760 h can be attributed to a variation in the manufacturing process. Koerner *et al.*<sup>39</sup> exposed a 1.5 mm-thick HDPE geomembrane for 28,000 h using a UV fluorescent weatherometer. The sample showed an approximately 20% higher decrease in the tensile properties (resistance and elongation) in comparison to the present study.

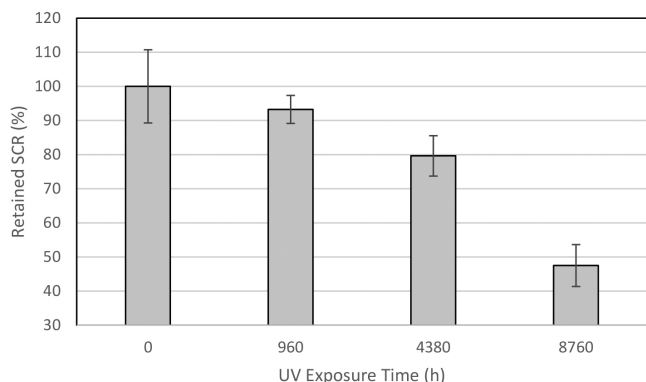
**Figure 3.** Retained SCR test results compared with virgin sample test result after UV fluorescent exposure

Table 4 shows the SCR test results for both virgin and UV fluorescent exposure samples after 960, 4380, and 8760 h and Figure 3 displays the behavior of the sample after exposure, exhibited in retained SCR.

The SCR results after 960, 4380, and 8760 h UV exposure decreased, respectively, 6.75, 20.36, and 52.48%, compared to the initial value. The SCR retained value after 1 year (8760 h) of laboratory UV exposure obtained in this study (47.52%) is similar to the SCR mean retained value reported by Rowe *et al.*<sup>41</sup> for eleven

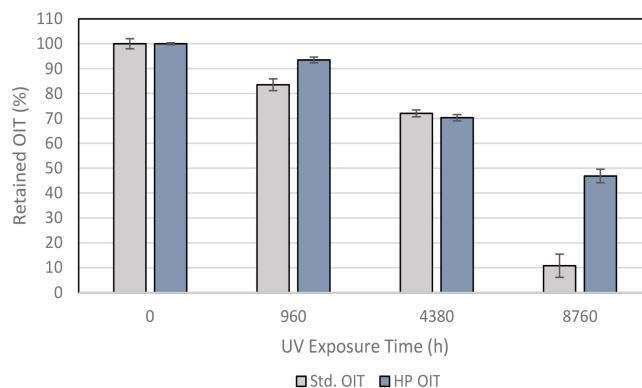
**Figure 4.** Retained Std. OIT and HP OIT tests results compared with virgin sample test result after UV fluorescent exposure

Table 5 shows the Std. OIT and HP OIT test results for both virgin and UV fluorescent exposure samples after 960, 4380, and 8760 h and Figure 4 displays the behavior of the samples after exposure, exhibited in retained OIT values.

The Std. OIT test results decreased 16.48, 27.99, and 89.19%, respectively, for 960, 4380, and 8760 h of UV exposure in comparison to the virgin sample result. A considerable decrease in the Std. OIT results was observed between 4380 and 8760 h of UV exposure. After 1-year exposure, the depletion of the antioxidants was almost complete and chain reaction and molecular composition started. Lavoie *et al.*<sup>42</sup> evaluated two 1.0 mm-thick exhumed HDPE geomembranes in mining facility constructions in Brazil and both showed low Std. OIT values, brittle tensile behavior, and low SCR values.

Nonetheless, the HP OIT test results decreased 6.52, 29.74, and 53.15%, respectively, for 960, 4380, and 8760 h of UV exposure compared to the initial value and decreased less than the Std. OIT test results. According to Abdelaal and Rowe,<sup>43</sup> the HP OIT test results after HDPE geomembrane samples heat exposure conducted to a high residual value. However, Lavoie *et al.*<sup>44,45</sup> obtained HP OIT value equal zero for one of the analyzed samples in the research, demonstrating that is possible to completely deplete the antioxidants for this test.

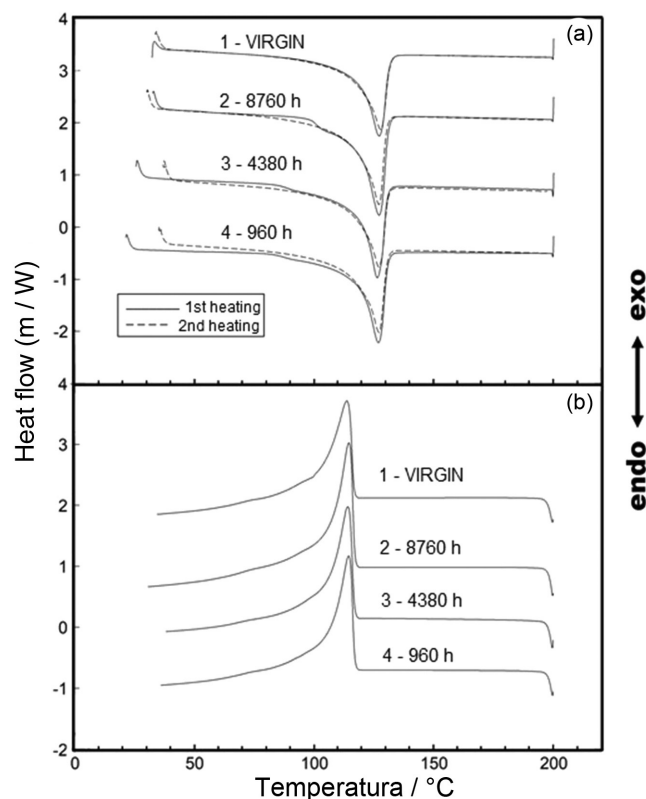
**Figure 5.** DSC curves: (a) melting point (heating) stage and (b) crystallisation (cooling) stage. (1) Virgin sample; (2) 8760 h UV fluorescent sample; (3) 4380 h UV fluorescent sample; and (4) 960 h UV fluorescent sample

Figure 5 shows the DSC curves for the first and second heatings (Figure 5a) to verify the behavior of melting point and cooling (Figure 5b) and understand the behavior of the crystallisation point. The first heating (except for the virgin sample) led to a deviation in the DSC curve before the melting point in the following temperature ranges: 96-105 °C for the 8760 h-sample, 82-93 °C for the 4380 h-sample, and 80-89 °C for the 960 h-sample. The deviation is attributed to the effect of exposure of the material to UV radiation, since no changes were observed in the DSC curve of the virgin sample. In the second heating, the samples exhibited a unique curve behavior due to the homogenization effect of the material after the first heating. Figure 5b shows that crystallisation is similar among the samples in function of the homogenization after melting. The homogenization caused by the material's melting displayed a new polymeric configuration, since the crystallisation points are coincident and the second evaluation of the melting point is also coincident. The essential DSC evaluation was the first heating analysis, which revealed a deviation from the samples' baseline.
